**Independent Expert Engineering Investigation and Review Panel  
Report on Mount Polley Tailings Storage Facility Breach  
Media Presentation**

**January 30, 2015**

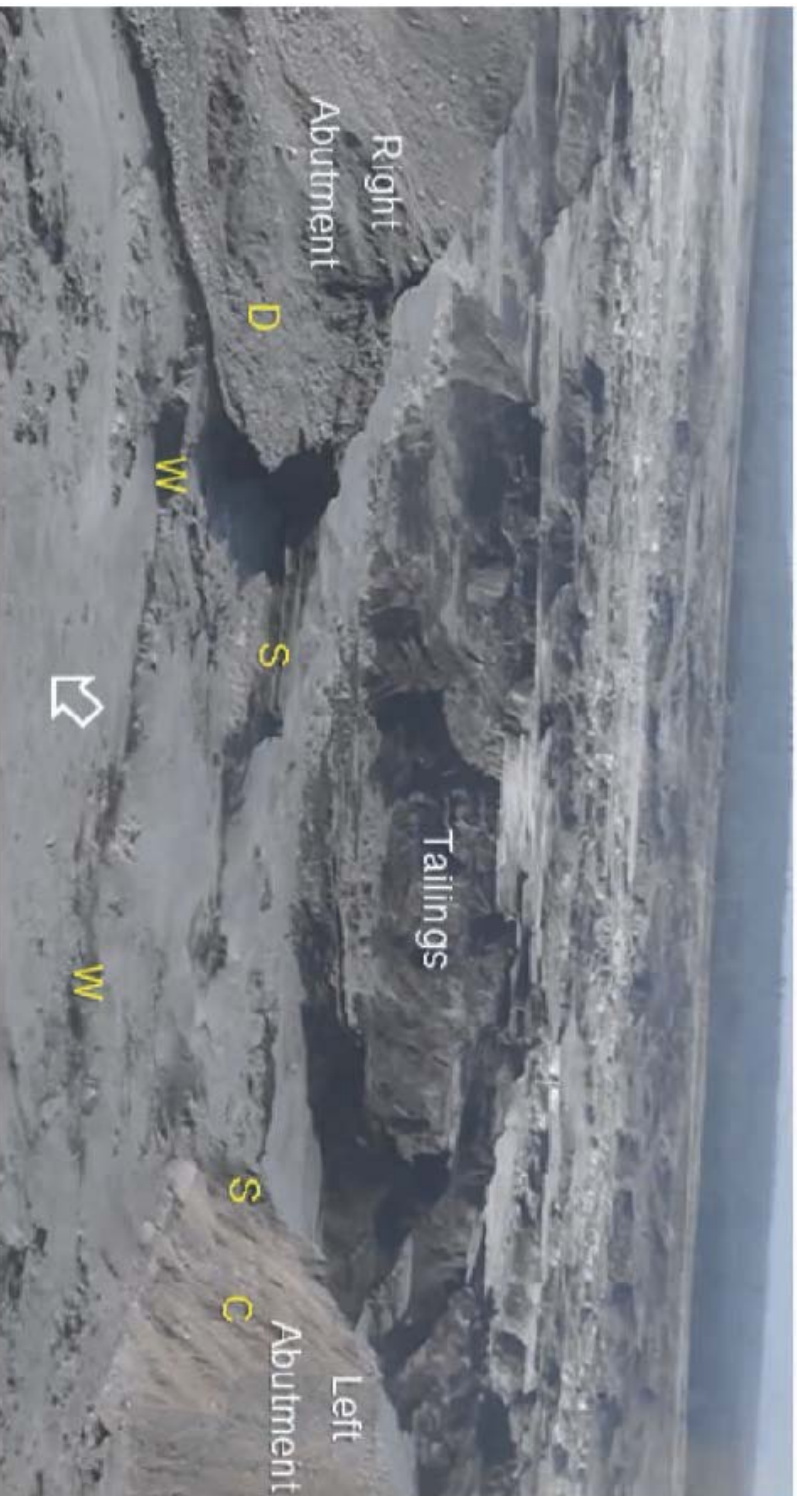
**FIGURE 5.1.1: VIEW LOOKING UPSTREAM THROUGH THE BREACH (ARROW SHOWS DIRECTION OF OUTFLOW)**

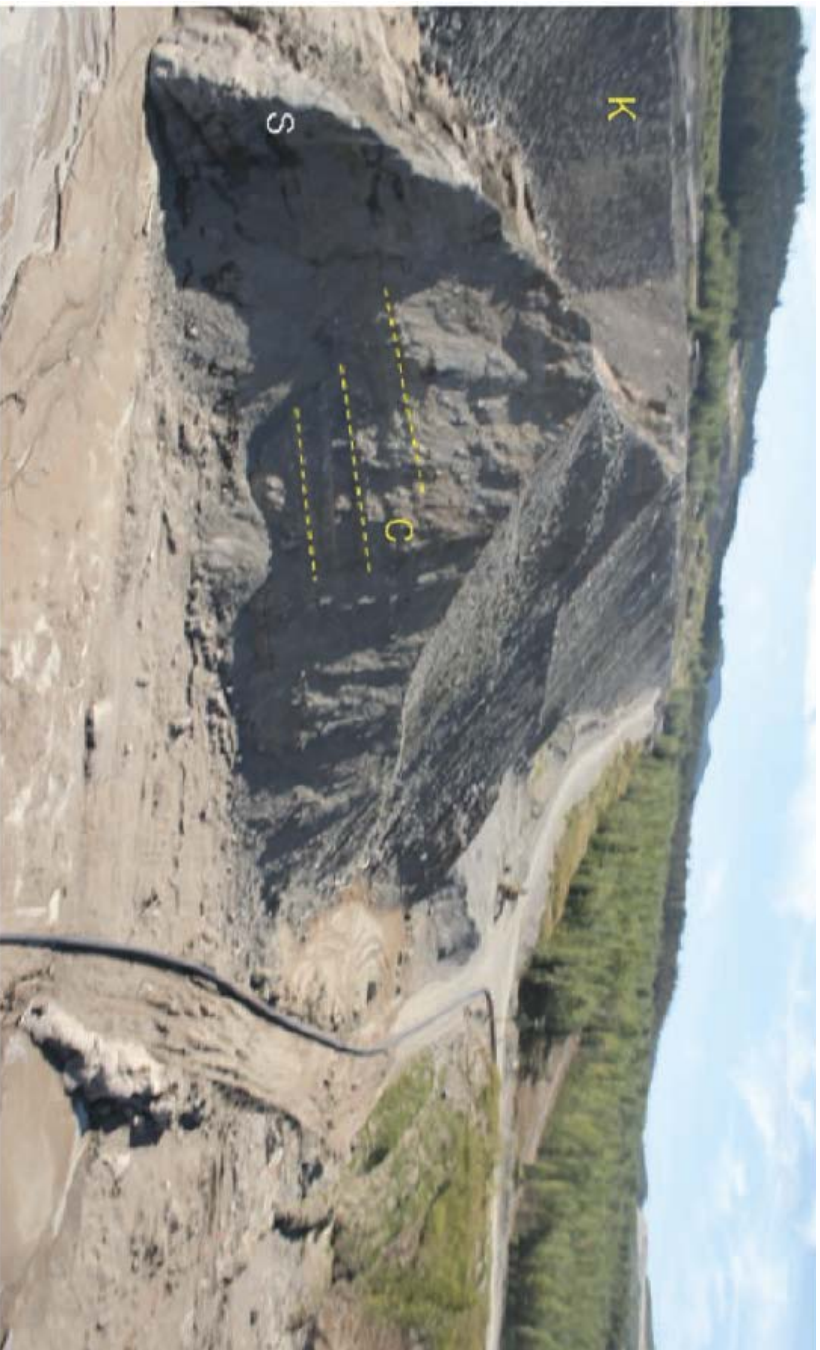
**FIGURE 5.1.5: APPARENT BEDDING ROTATION ON LEFT ABUTMENT OF BREACH (SEPT. 4, 2014 PHOTO)**

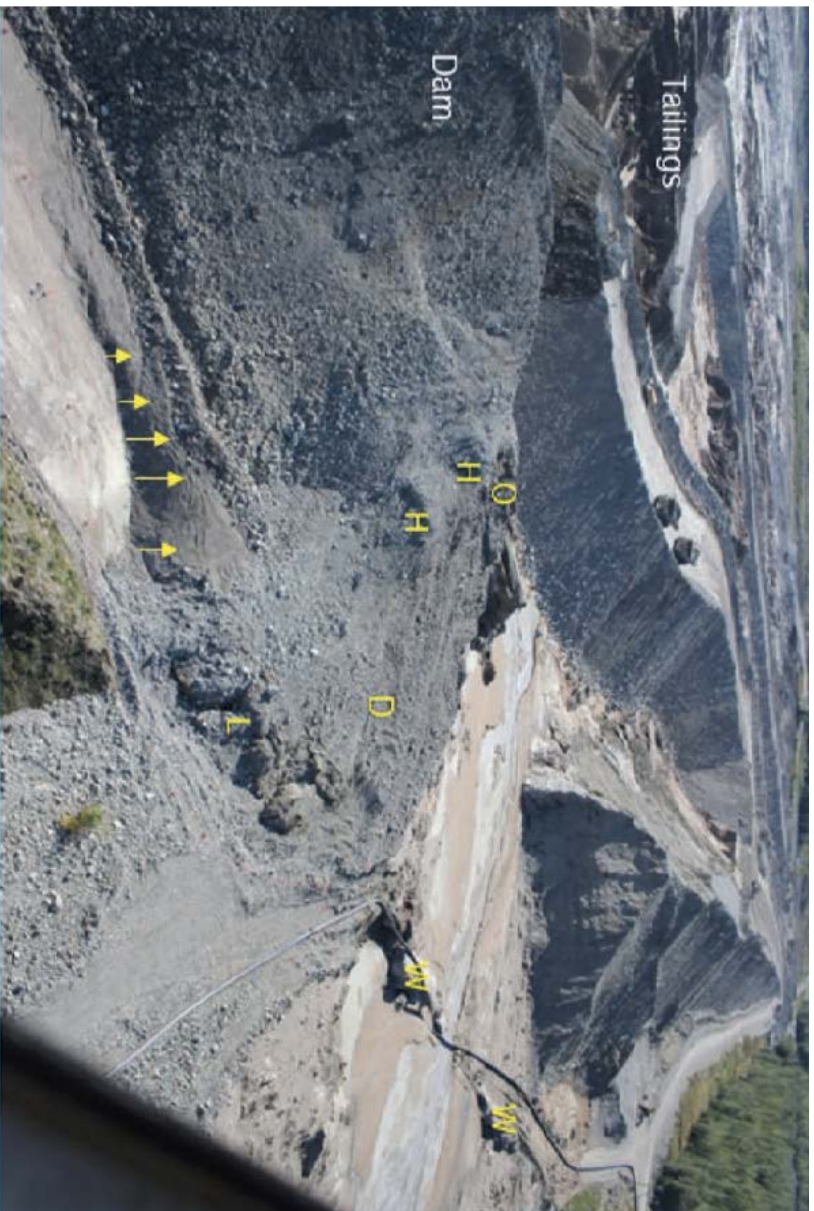
FIGURE 5.1.6: SLIDING-RELATED FEATURES AT RIGHT ABUTMENT (SEPT. 4, 2014 PHOTO)

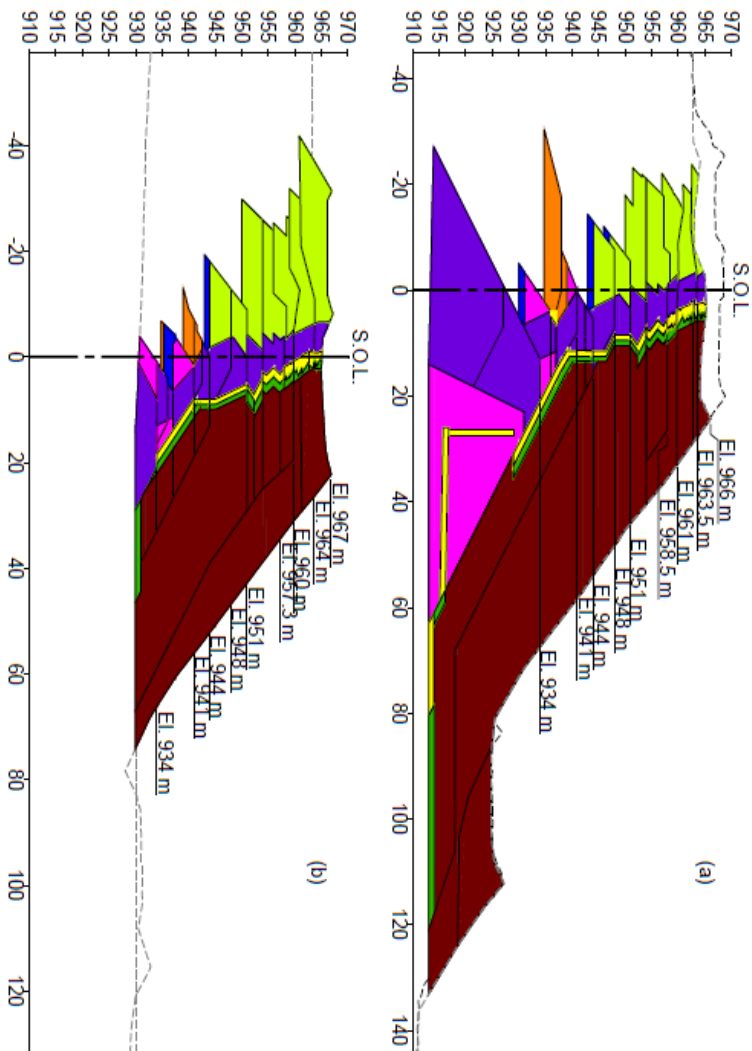
**FIGURE 5.4.10: DAM CONFIGURATION ON AUGUST 3, 2014. (a) MAIN EMBANKMENT (b) PERIMETER EMBANKMENT AT BREACH SECTION**

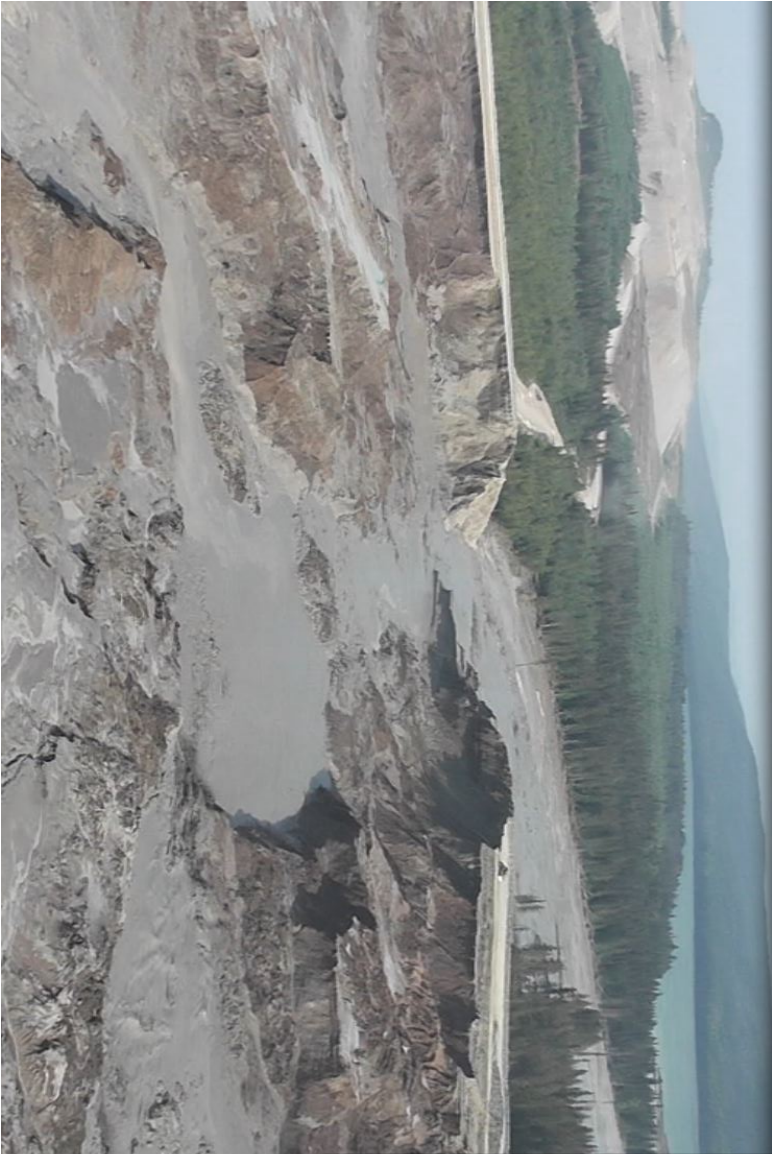
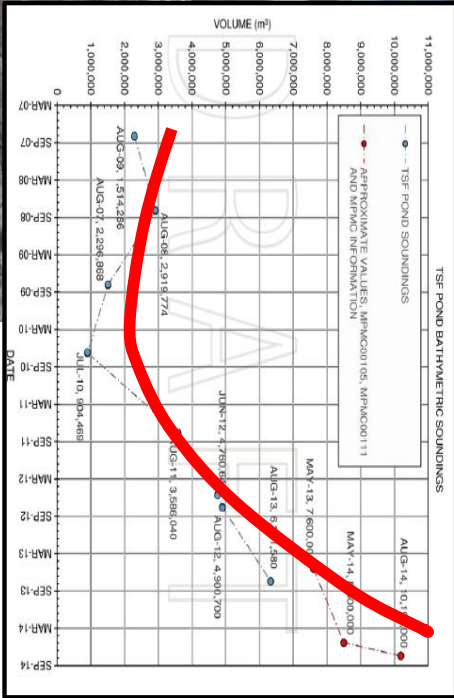
- Most of the tailings were released by erosion from the large volume of water available

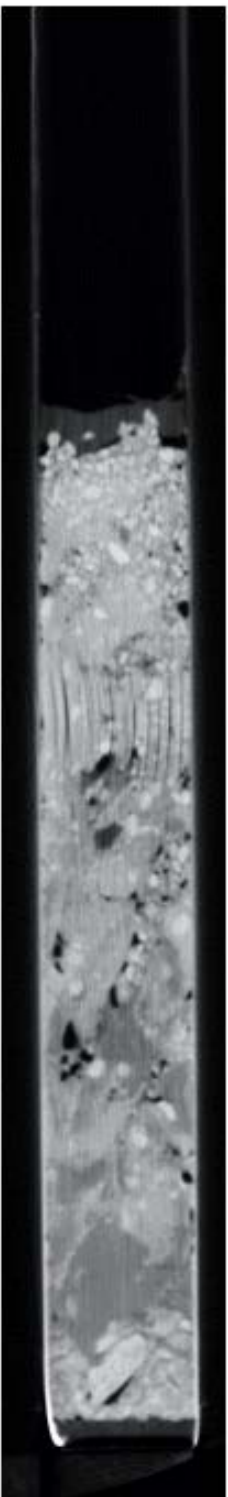
TILL SAMPLE (MR14-104-SA8)

DEPTH: 11.4 TO 12.0 M / EL. 920.3 TO 919.7 M

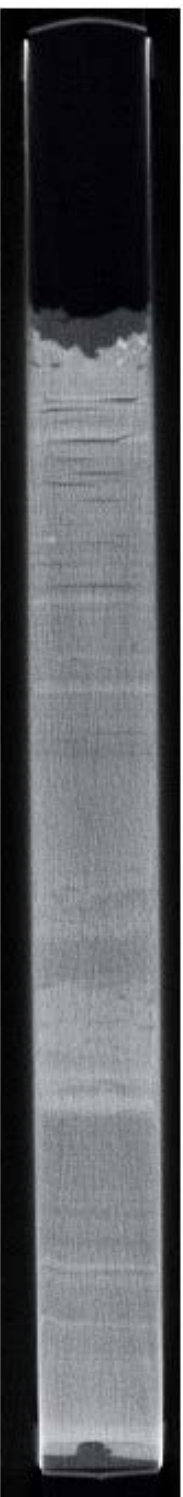
UPPER GLU SAMPLE (MR14-106E-SA3)

DEPTH: 8.2 TO 8.8 M / EL. 920.5 TO 919.9 M

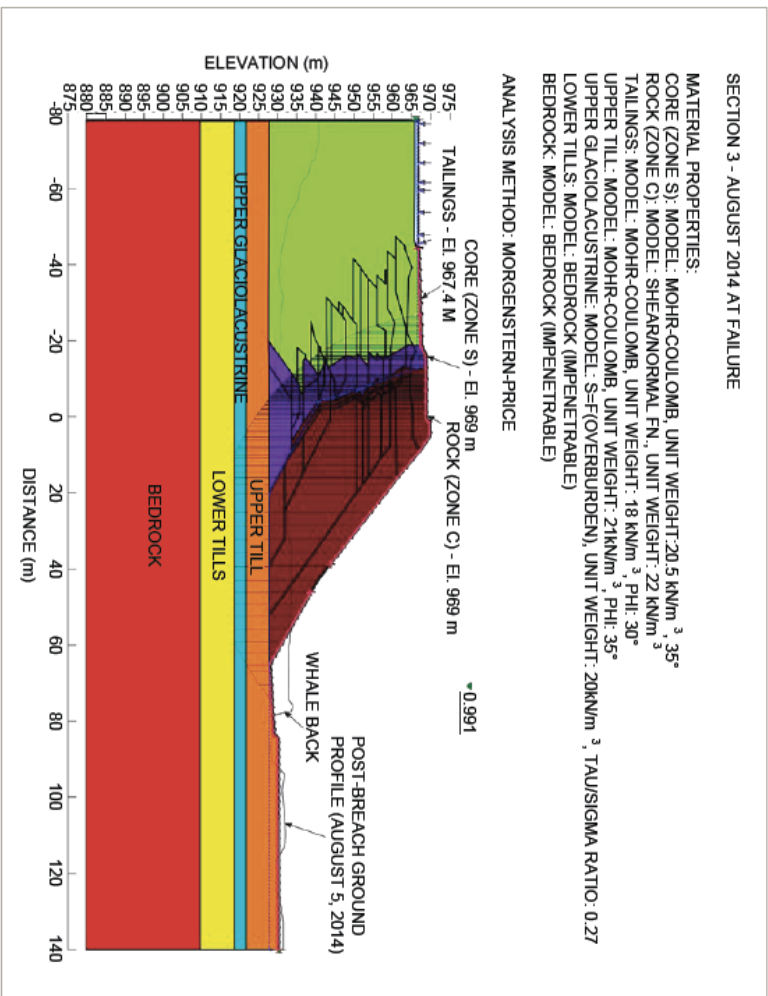
FIGURE 6.2-1: DETAILED SECTION USED FOR LIMIT EQUILIBRIUM ANALYSIS (HIGH WATER TABLE, UNDRAINED STRENGTH RATIO 0.27)

- The root cause of the breach was the undrained failure of the Upper GLU under the imposed load of the Perimeter Embankment on August 4, 2014.
- The design did not take into account the complexity of the sub-glacial and pre-glacial geological environment associated with the Perimeter Embankment foundation.
- The omissions associated with site characterization may be likened to creating a loaded gun.
- If constructing unknowingly on the Upper GLU constituted loading the gun, building with a 1.3H:1V angle of repose slope over this stratum pulled the trigger.
