**Independent Expert Engineering Investigation and Review Panel**

# **Report on Mount Polley Tailings Storage Facility Breach**

**January 30, 2015**

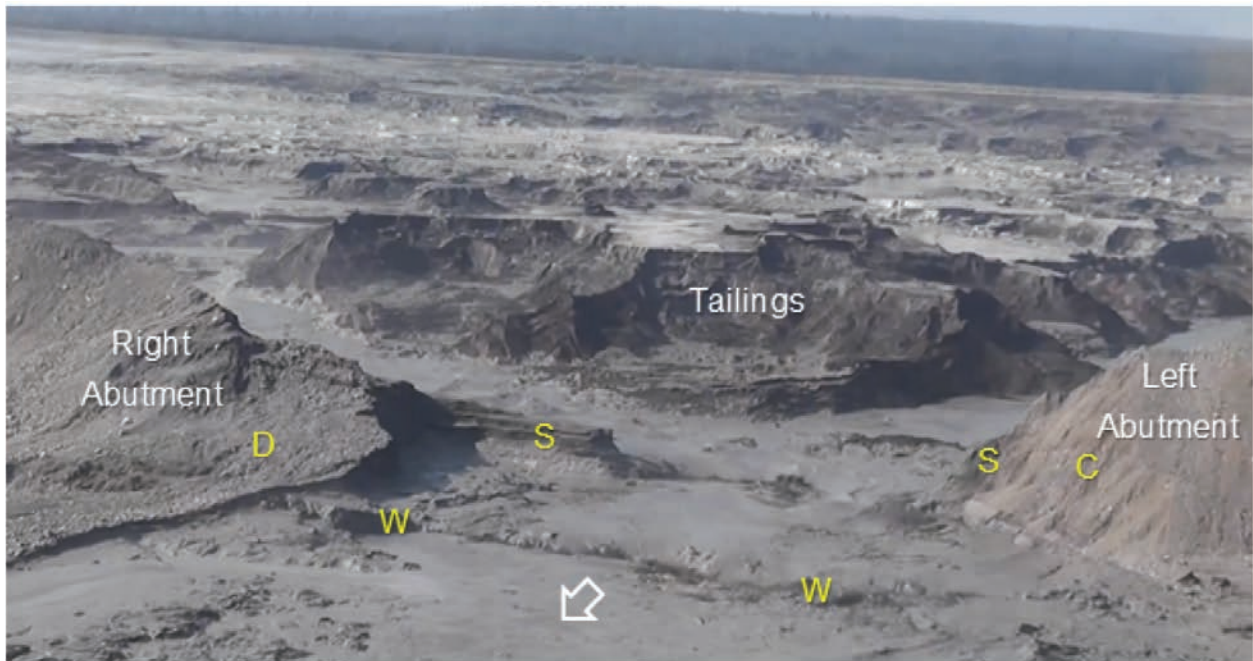
**FIGURE 5.1.1: VIEW LOOKING UPSTREAM THROUGH THE BREACH (ARROW SHOWS DIRECTION OF OUTFLOW)**

The labelled features in **Figure 5.1.1** can be interpreted with reference to the internal zoning of the dam previously provided as **Figure 4.1.1**. On the upstream side of the breach, remnant projections of the dam core (S) can be seen on the left and right abutments. The projection on the right abutment acts like a jetty in directing flow toward the left abutment.

Zone C rockfill (C) is exposed on the left abutment, where it has been eroded by these redirected breach outflows. On the right abutment, the surface of the displaced rockfill (D) was subject to erosional overflow during earlier stages of breach development. It was subsequently protected from erosional undercutting in the main channel by the projecting core remnant and eddies that developed downstream.

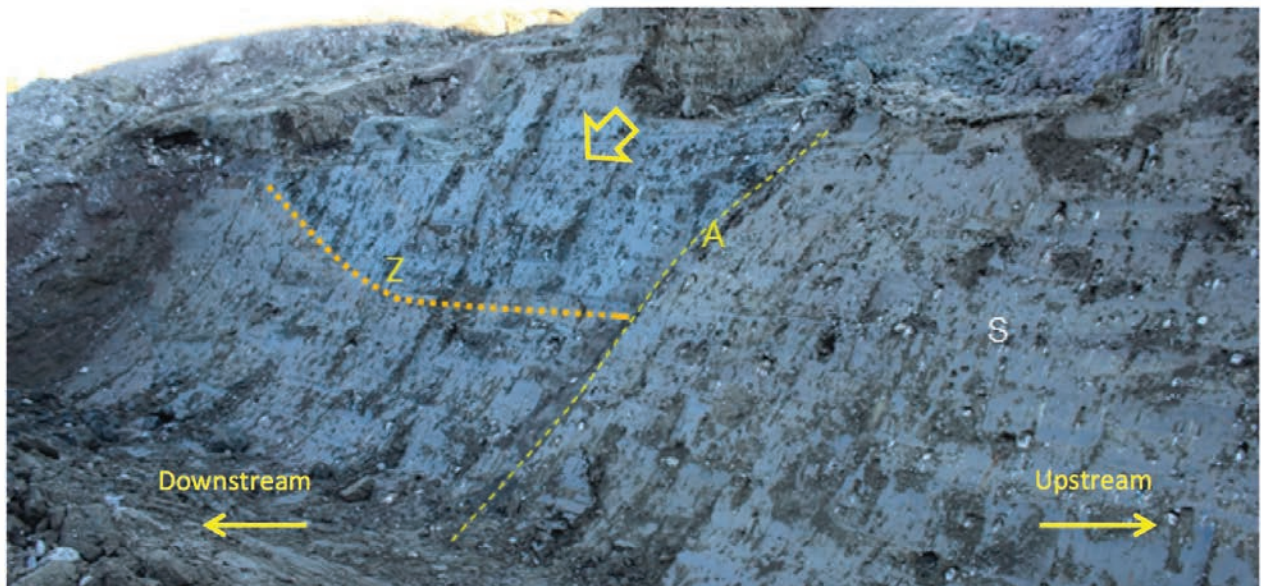
**FIGURE 5.1.3: SHEAR SURFACE THROUGH REMNANT DAM CORE (ARROW INDICATES DIRECTION OF DOWNDROP)**

The surface trace and 3-D orientation of the shear are shown on the core remnant in Figure 5.1.4, with a dip angle and direction as indicated.

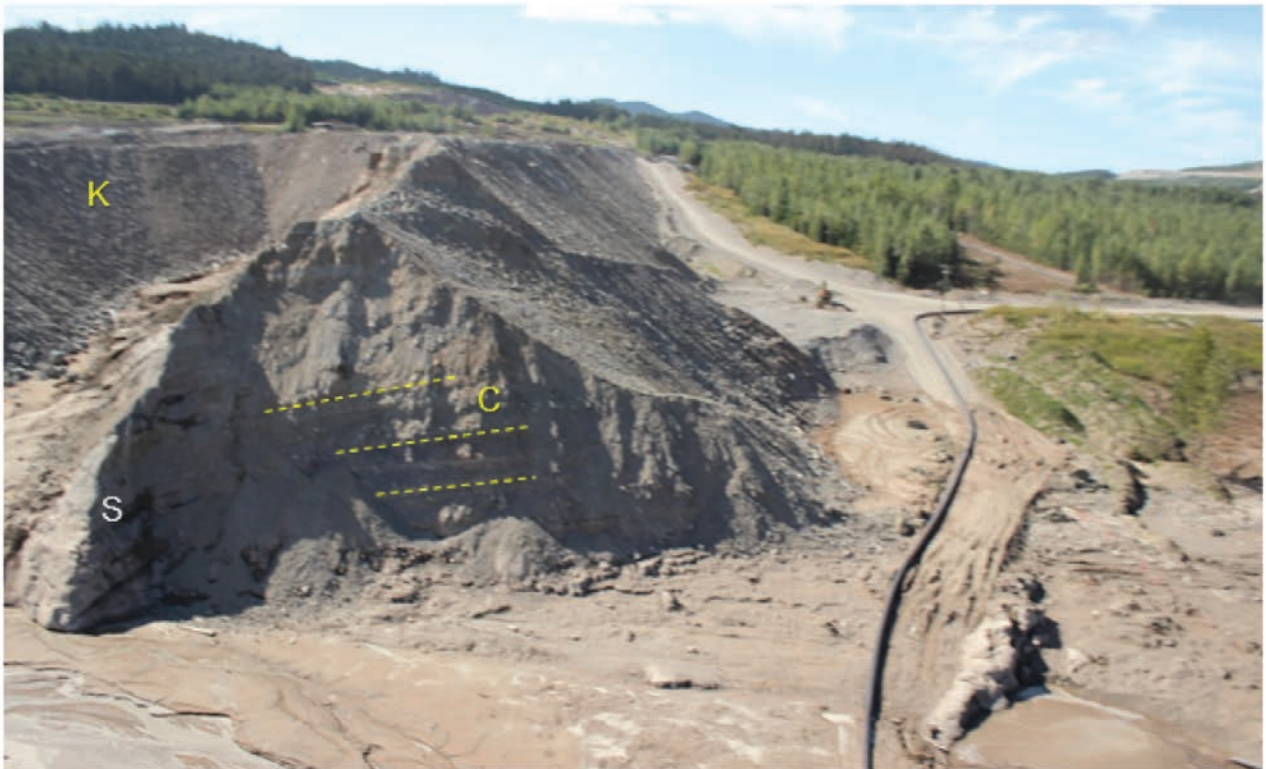
**FIGURE 5.1.5: APPARENT BEDDING ROTATION ON LEFT ABUTMENT OF BREACH (SEPT. 4, 2014 PHOTO)**

Other artifacts of foundation sliding are evident elsewhere. As indicated in **Figure 5.1.5**, lift lines in the Zone C rockfill on the left abutment (C) are tilted at an inclination of 7° to 10°, with corollary inclinations on the right abutment of 5° to 14°. Also shown in **Figure 5.1.5** are the Zone S core (S), with a containment dike (K) under construction in the background. Scarps higher on the left abutment were produced by post-sliding downdrop of large slump blocks into the breach due to erosional undercutting at foundation level.

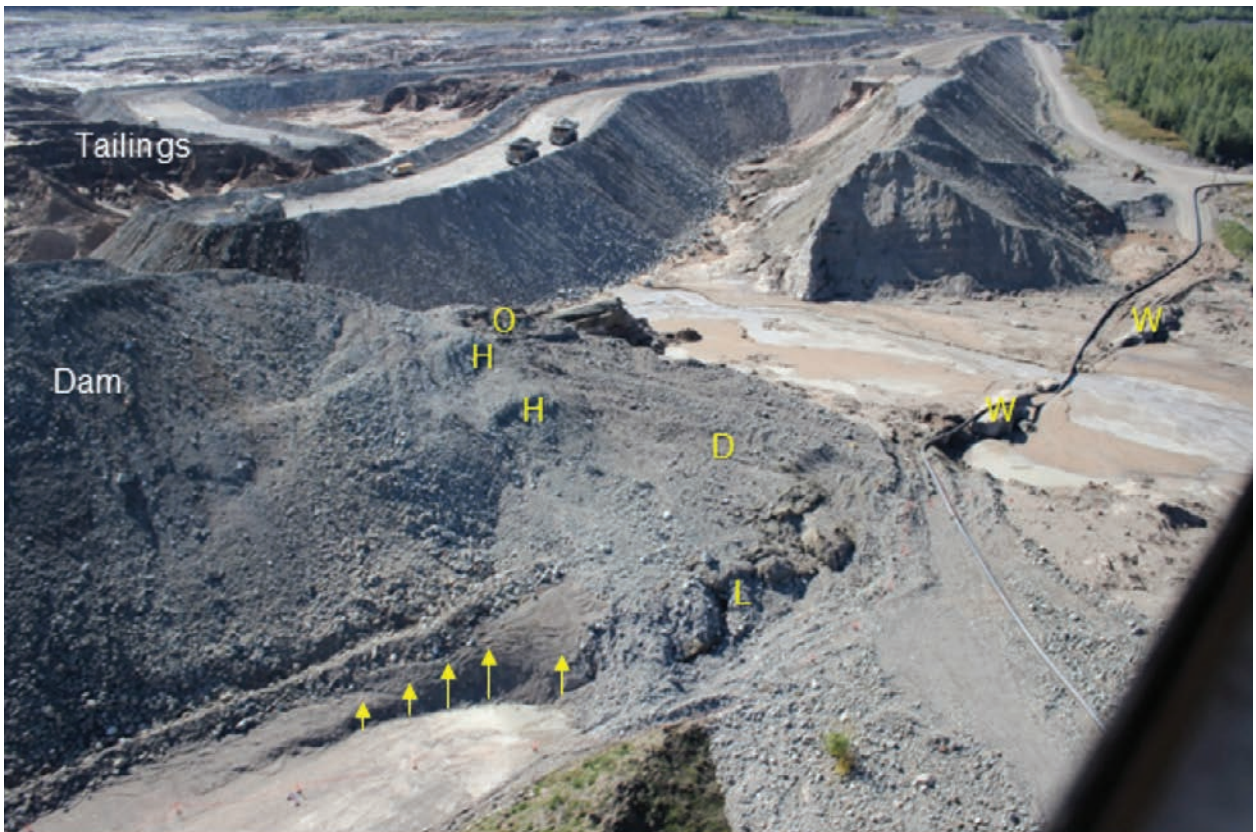
**FIGURE 5.1.6: SLIDING-RELATED FEATURES AT RIGHT ABUTMENT (SEPT. 4, 2014 PHOTO)**

**Figure 5.1.6** shows the right abutment, with the left abutment in the background. Noteworthy features include open cracks (O) and headscarps (H) at higher elevations. At the downstream toe, upthrust of foundation till (L) ranging from 2.8 m to 3.5 m has occurred along an alignment collinear with the whaleback (W).

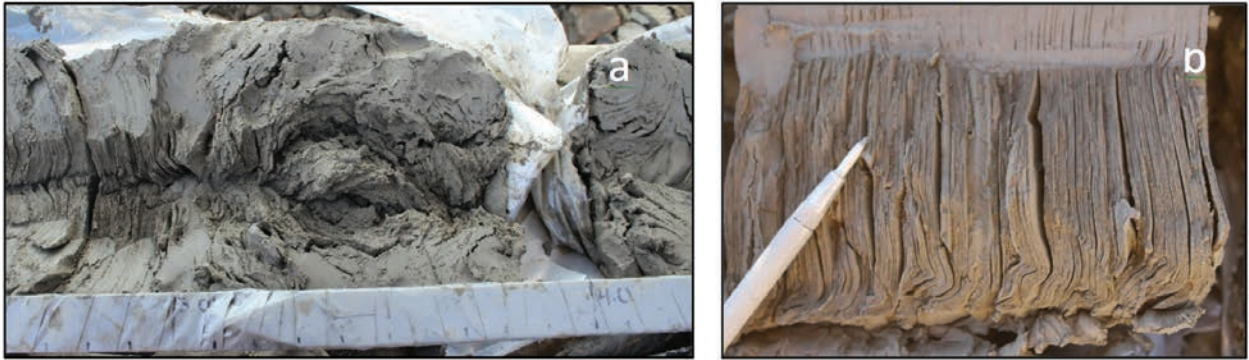
**FIGURE 5.2.8 UPPER GLU (a) INSIDE THE BREACH, (b) OUTSIDE THE BREACH**

The thinly laminated, planar varving outside the breach contrasts sharply with the contorted and folded laminations within it. This is consistent with shearing of the Upper GLU having occurred within the breach.

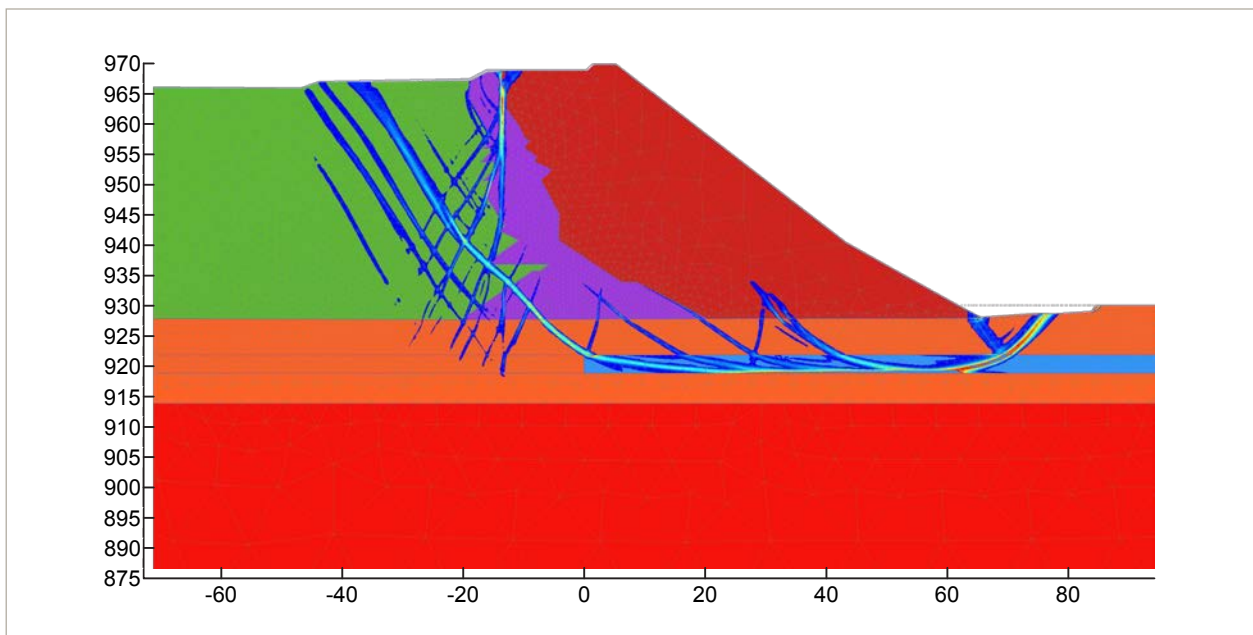
**FIGURE 6.2.3: PLAXIS MODEL AT COLLAPSE (UNDRAINED STRENGTH RATIO 0.29)**

Both the entry and exit of the failure surface in the foundation correspond closely with field observations summarized in **Figure C4.2.2** in Appendix C.
