**Independent Expert Engineering Investigation and Review Panel  
Report on Mount Polley Tailings Storage Facility Breach  
Media Presentation**

**January 30, 2015**

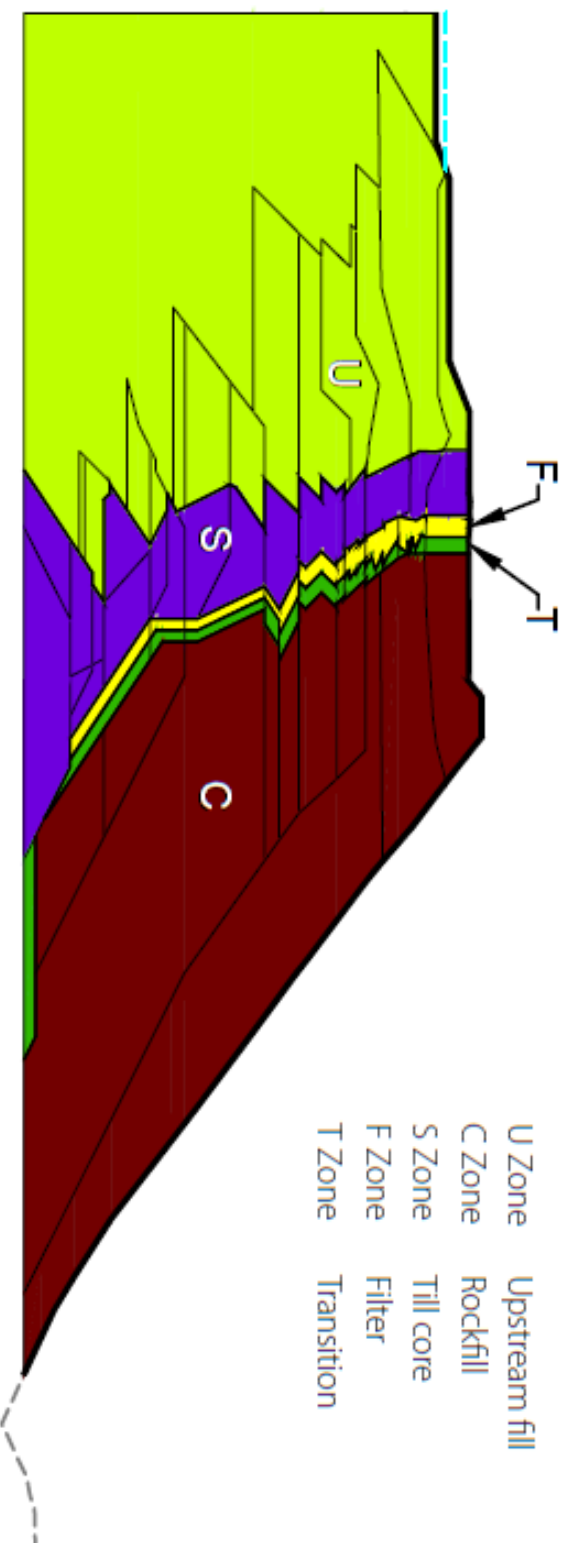
FIGURE 4.1.1: SIMPLIFIED CROSS-SECTION OF THE MOUNT POLLEY DAM

- The Panel concluded that evidence indicates the breach was the result of failure in the foundation of the embankment, a failure that occurred in a glaciolacustrine (GLU) layer of the embankment's foundation.
- According to the Panel's report: "The Panel concluded that the dominant contribution to the failure resides in the design. The design did not take into the account the complexity of the sub-glacial and pre-glacial geological environment associated with the perimeter embankment foundation. As a result, foundation investigations and associated site characterization failed to identify a continuous GLU layer in the vicinity of the breach and to recognize that it was susceptible to undrained failure when subject to the stresses associated with the embankment."

- The root cause of the breach was the undrained failure of the Upper GLU under the imposed load of the Perimeter Embankment on August 4, 2014.
- The design did not take into account the complexity of the sub-glacial and pre-glacial geological environment associated with the Perimeter Embankment foundation.
- The omissions associated with site characterization may be likened to creating a loaded gun.
- If constructing unknowingly on the Upper GLU constituted loading the gun, building with a 1.3H:1V angle of repose slope over this stratum pulled the trigger.
