**Independent Expert Engineering Investigation and Review Panel**

# **Report on Mount Polley Tailings Storage Facility Breach**

**January 30, 2015**

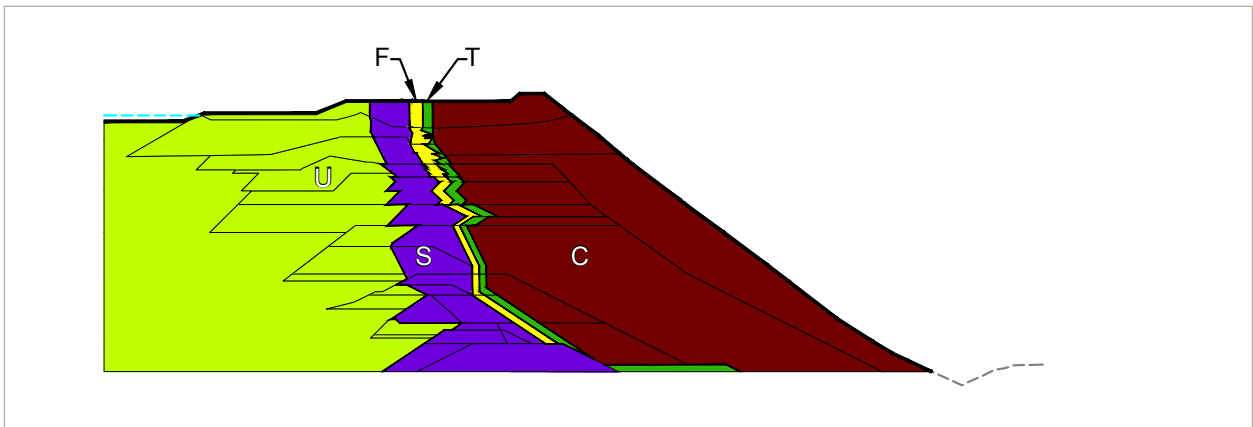
**FIGURE 4.1.1: SIMPLIFIED CROSS-SECTION OF THE MOUNT POLLEY DAM**

**Figure 4.1.1** shows a simplified cross-section of the dam. It is constructed of both earth and rockfill and would be classified as a zoned earth and rockfill dam. The specific zones are:

U Zone	Upstream fill
C Zone	Rockfill
S Zone	Till core
F Zone	Filter
T Zone	Transition

The impervious element of the dam is the till core (Zone S), composed of glacial deposits (till) excavated from selected borrow areas. The duty of the rockfill zone (Zone C) is to support the core, without which the core would not be stable. When seepage flows through the core or if it became cracked, its relatively fine-grained material might erode into the rockfill. The duty of the filter (Zone F) and transition (Zone T) is to collect any seepage coming through the core and to prevent fines from migrating out of it. Zone T is a transition to Zone C and it is intended to stop migration of filter material into Zone C. While Zone C is somewhat compacted to improve its density, this is not sufficient to preclude migration of Zone F into Zone C. Hence, a transition Zone T is needed.

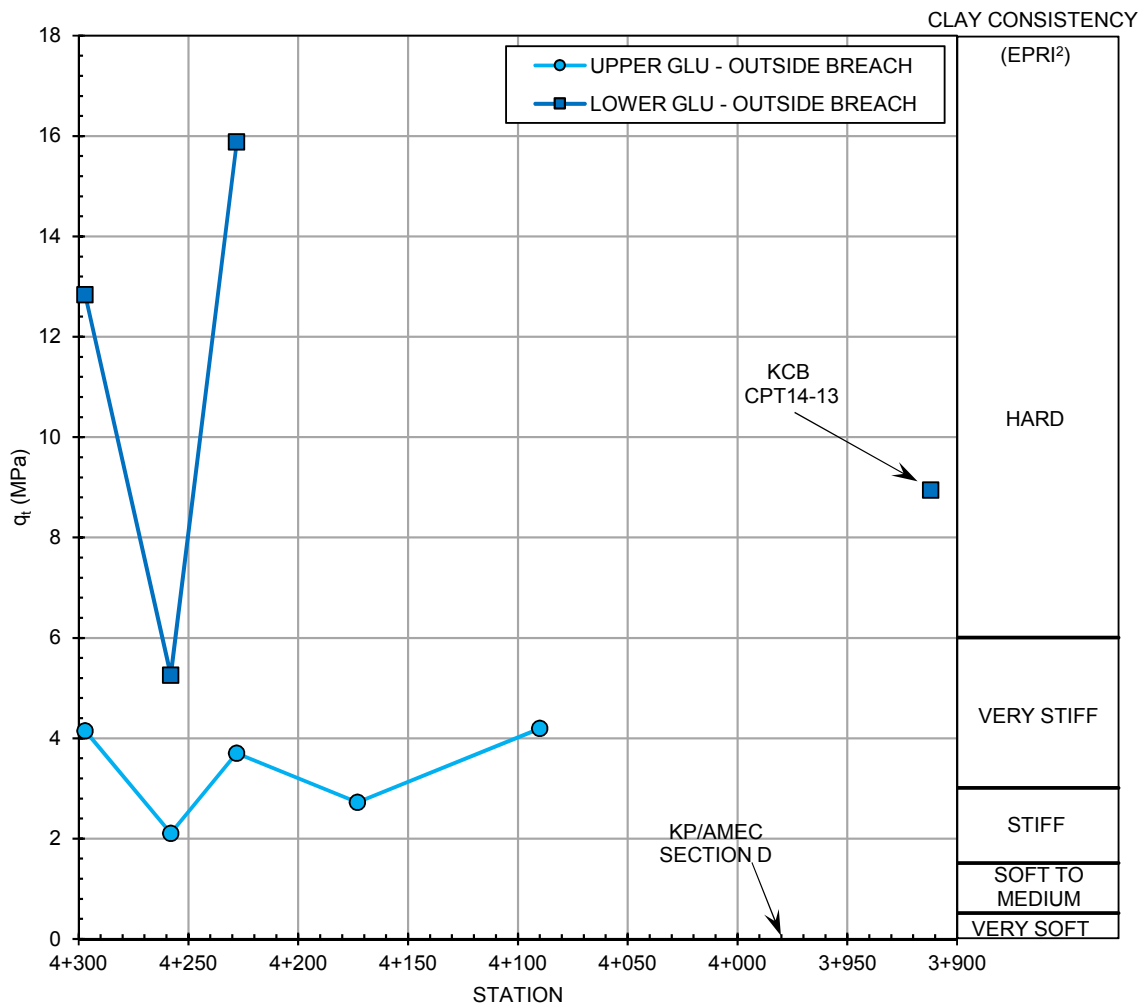
**FIGURE 5.2.4: LONGITUDINAL VARIATION IN CPT TIP RESISTANCE**

Secondly, CPT tip resistance in the two units is distinctly different. **Figure 5.2.4** shows that tip resistance  $q_t$  for the Upper GLU is less than one-half of that for the Lower GLU across the breach area. Using  $q_t$  as a measure of clay consistency, the Upper GLU classifies as stiff to very stiff, while the Lower GLU classifies as very stiff to hard.

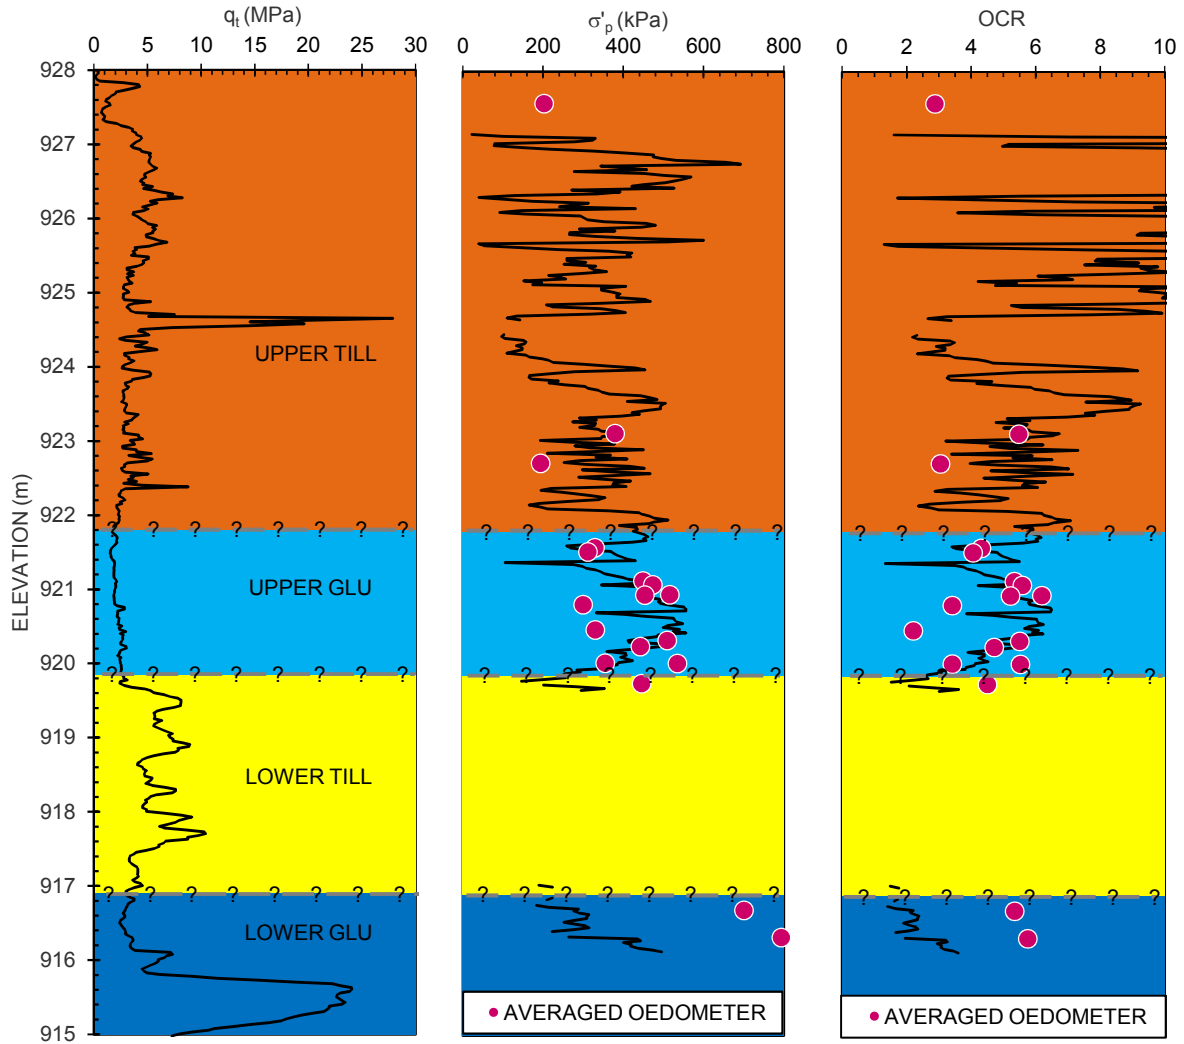
**FIGURE 5.2.5: INITIAL (PRE-CONSTRUCTION) STRESS HISTORY**

The continuous plots of  $\sigma'_p$  and OCR adopt published CPT correlations,<sup>2</sup> while the laboratory-derived data points are taken from Appendix E. From laboratory data, the average  $\sigma'_p$  for the Upper and Lower GLU units is 433 kilopascals (kPa) and 748 kPa respectively, with corresponding OCRs of 6.0 and 6.9.

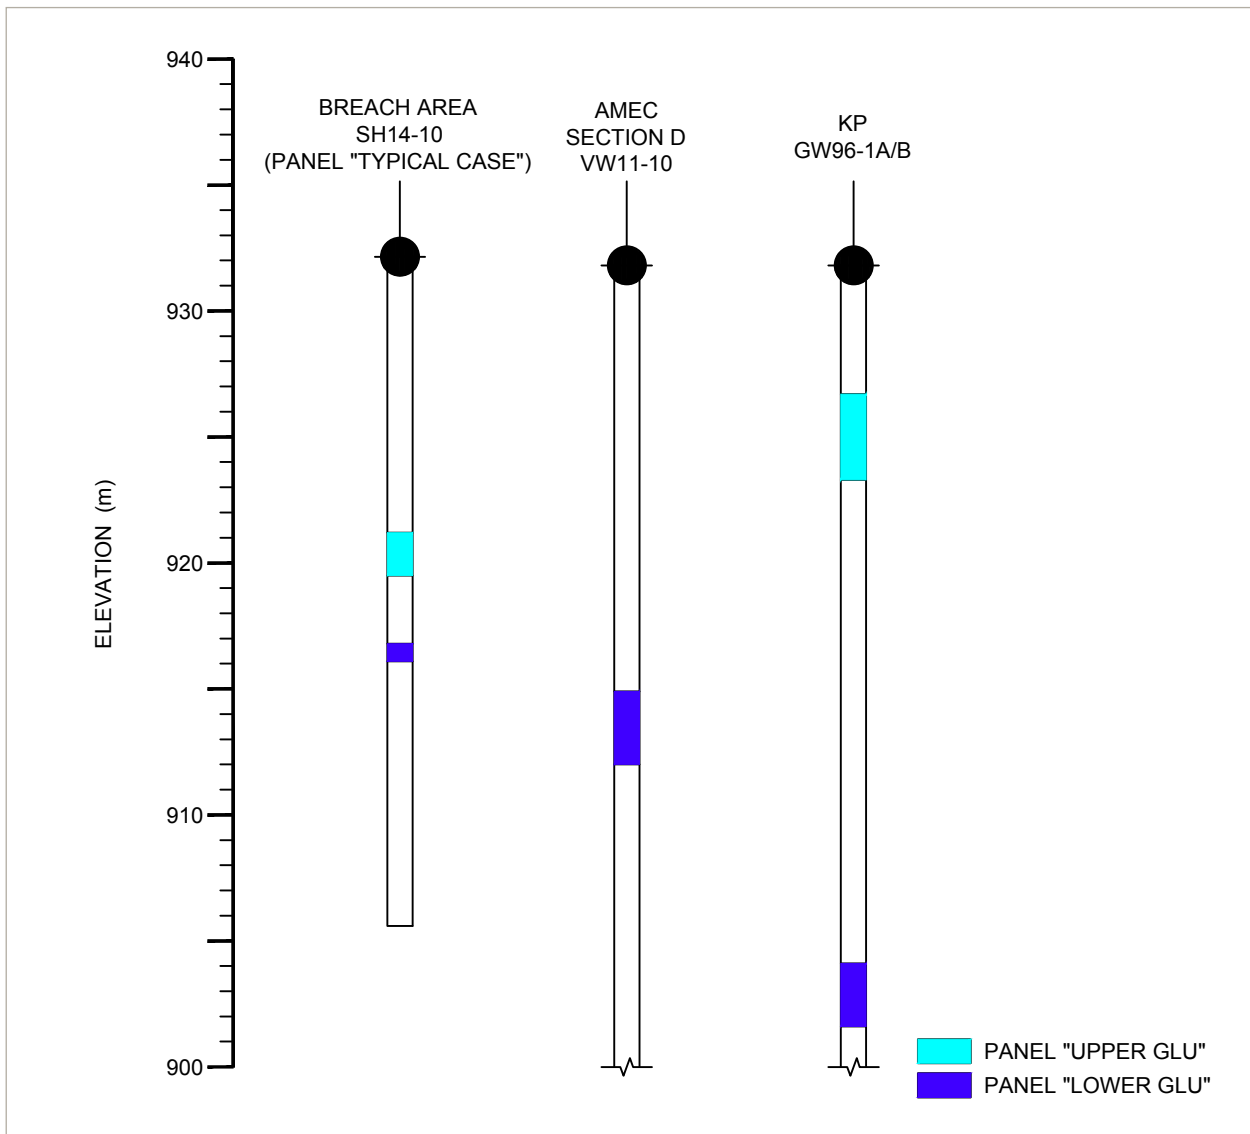
**FIGURE 5.2.7: COMPARISON OF GLU UNITS IN BREACH TO OTHER AREAS**

Stratigraphic variations on a larger scale are also apparent from **Figure 5.2.7**, which relates the Upper and Lower GLU units at the breach to glaciolacustrine soils elsewhere at boring locations presented previously in **Figure 5.2.2**. The Upper GLU at the breach shows apparent similarities to glaciolacustrine soils at similar elevation in GW96-1A that would be characterized as soft to medium-stiff according to their standard penetration test (SPT) blow count of 6. On the other hand, the uppermost GLU layer encountered in VW11-10 has an average water content of 23%, which corresponds closely to that of the Lower GLU shown in **Table 5.2.1**. Details are provided in Appendix D.

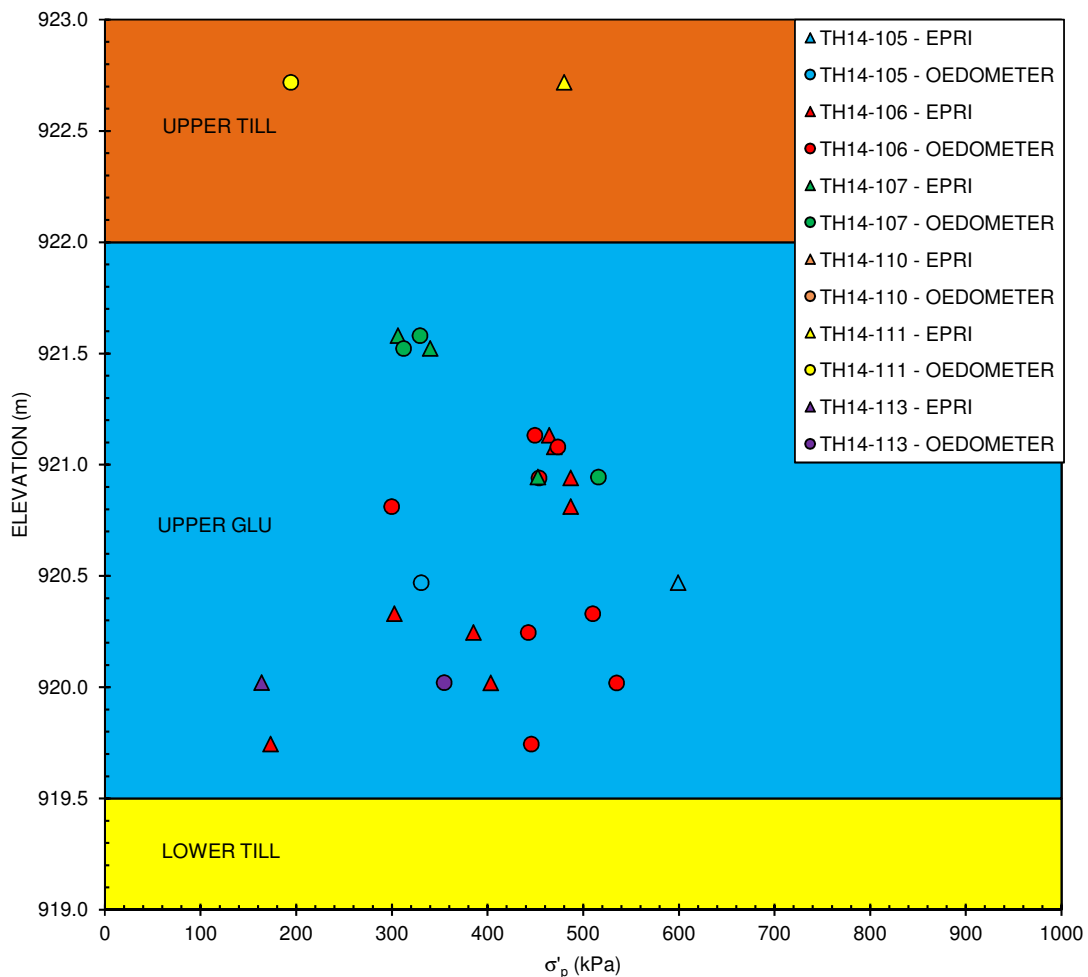
**FIGURE 5.3.3: PRECONSOLIDATION PRESSURE WITH ELEVATION**

Preconsolidation pressure can also be inferred from the CPT testing conducted as part of the Panel's site investigation. Again, only modest preconsolidation stresses have been determined. A comparison between the results obtained from the field tests with those obtained from the oedometer tests is shown in **Figure 5.3.3**, and the agreement is acceptable. As the embankment was raised to a stress level beyond the preconsolidation stresses, the underlying GLU reverted to normally consolidated behaviour.

**As the embankment was raised to a stress level beyond the preconsolidation stresses, the underlying GLU reverted to normally consolidated behaviour.**

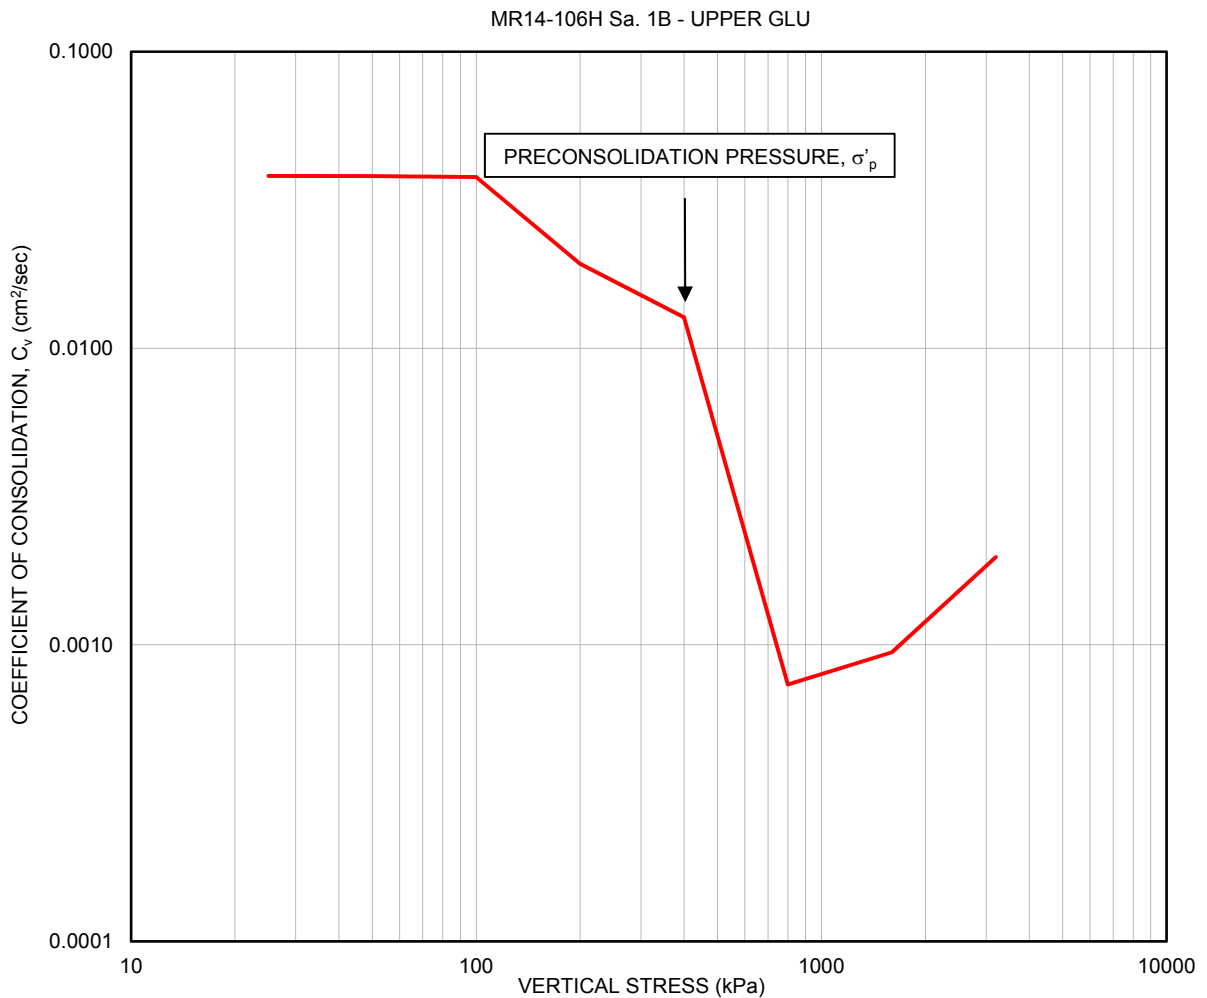
**FIGURE 5.3.4: VARIATION OF COEFFICIENT OF CONSOLIDATION WITH APPLIED VERTICAL STRESS**

The data from oedometer tests are presented in Appendix E, including information on the coefficient of consolidation that reflects the rate of pore pressure dissipation on loading. **Figure 5.3.4** provides an example of this response. The significant reduction in this value in the GLU at pressures in excess of the preconsolidation stress is noteworthy.

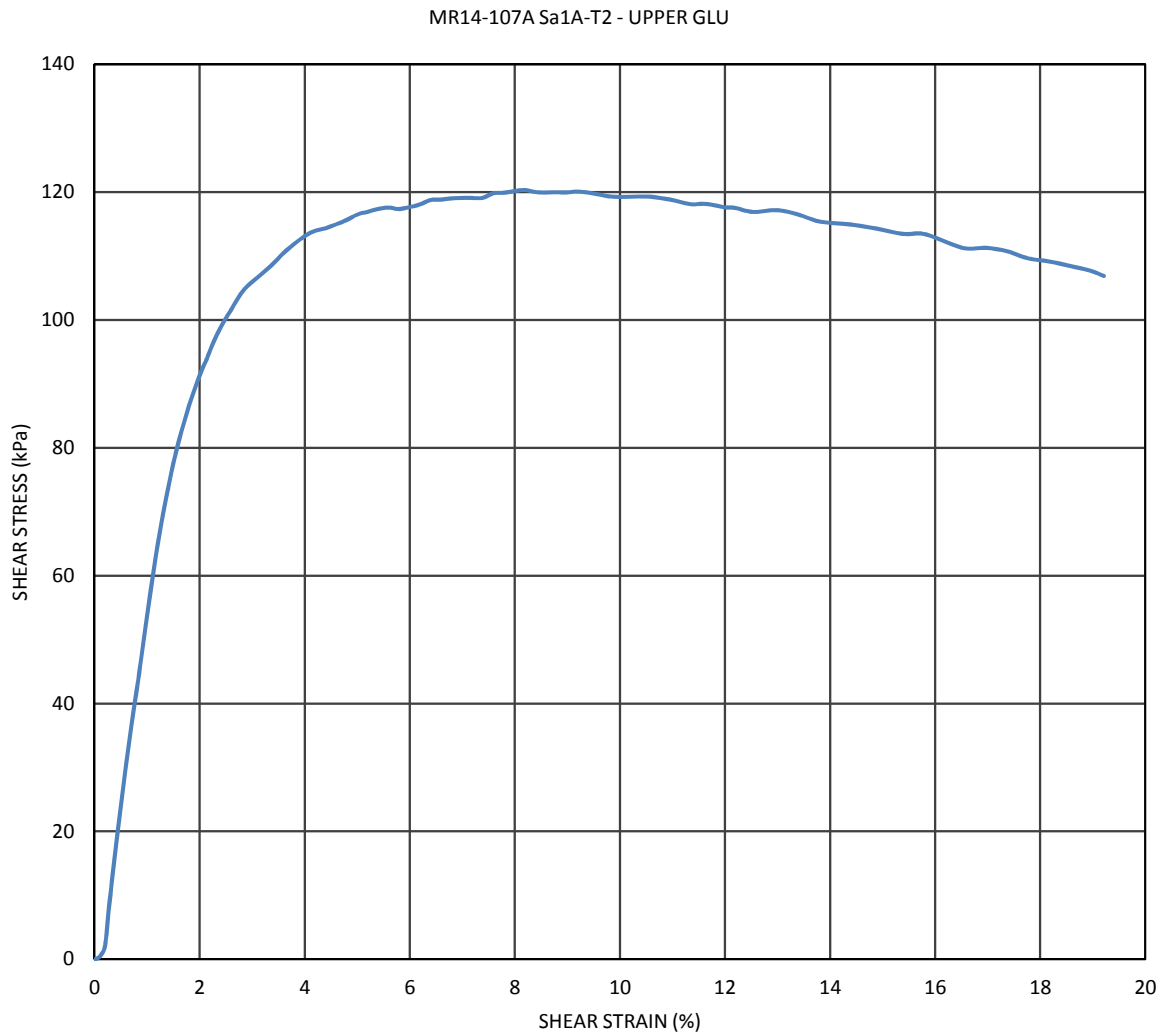
FIGURE 5.3.5: DSS TEST: GLU WITH STRAIN WEAKENING

Another important feature exhibited by this test program on GLU specimens is a decline in resistance following its peak. This is called strain weakening. An example of a test exhibiting strain weakening is shown in **Figure 5.3.5**. As will be discussed, the presence of strain weakening contributes to understanding of the sudden nature of the breach mechanism. **Table 5.3.1** summarizes test characteristics and results from the DSS test program. Complete test results, with a brief description of test methodology, are presented in Appendix E.

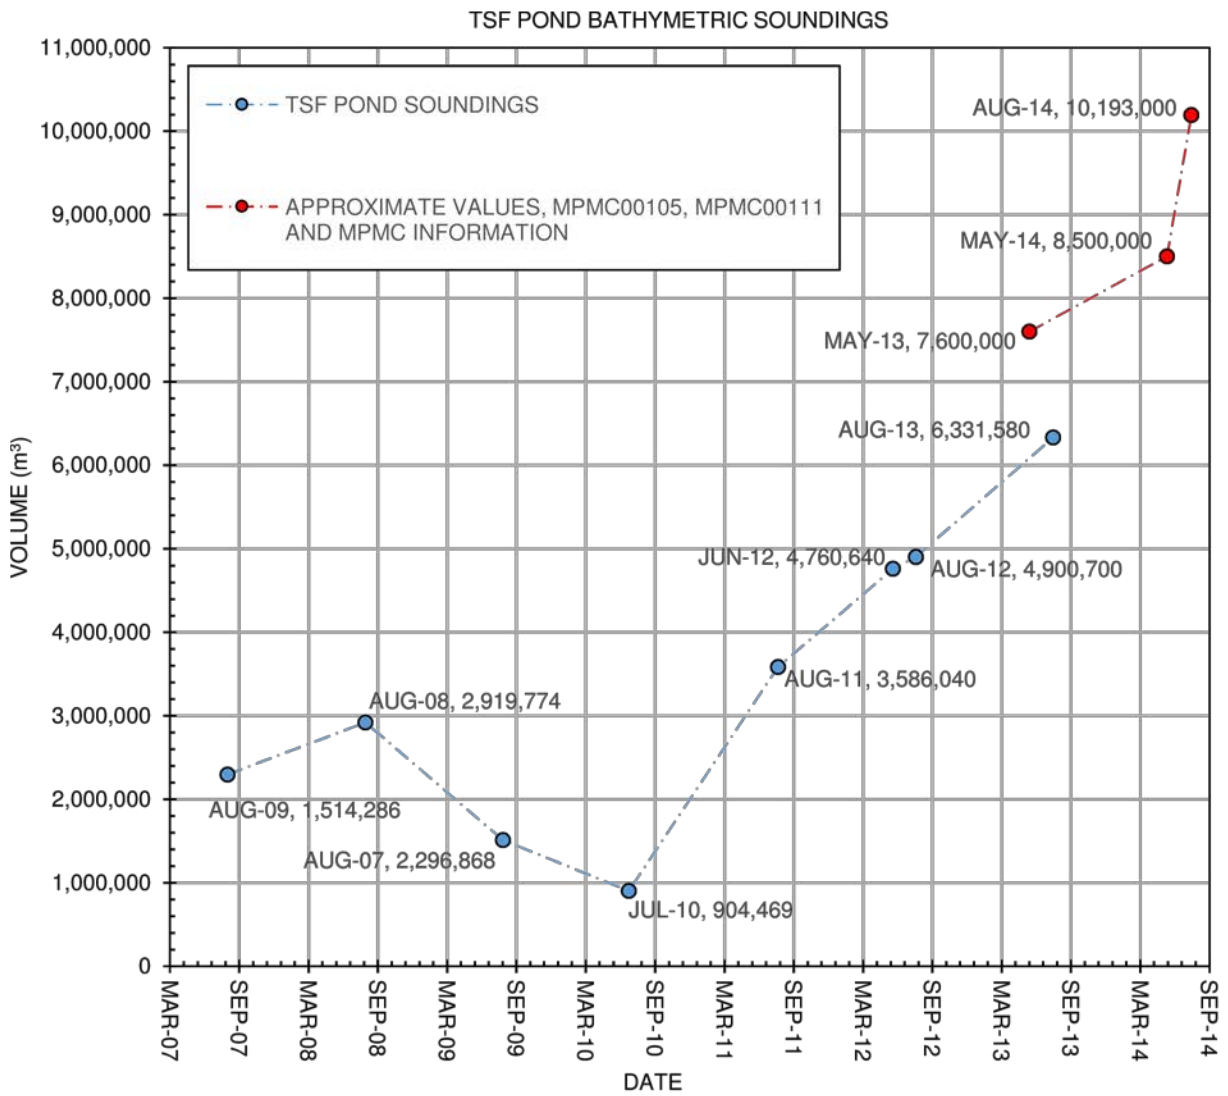
FIGURE 5.6.1: WATER ACCUMULATION IN TSF

**Figure 5.6.1** shows the accumulation of water in the TSF as determined from bathymetric surveys. The figure also shows approximate volumes reported in the records for three dates (refer to Appendix G).

MPMC was aware of the water surplus conditions at the start of Phase 2 operations. The pond volumes in **Figure 5.6.1** show that the last number of embankment raises were necessary to store water and not necessarily much higher tailings production. It is not clear to the Panel why it took so long to design and implement a water treatment strategy that would provide for a significant reduction in the amount of surplus water stored on the TSF.

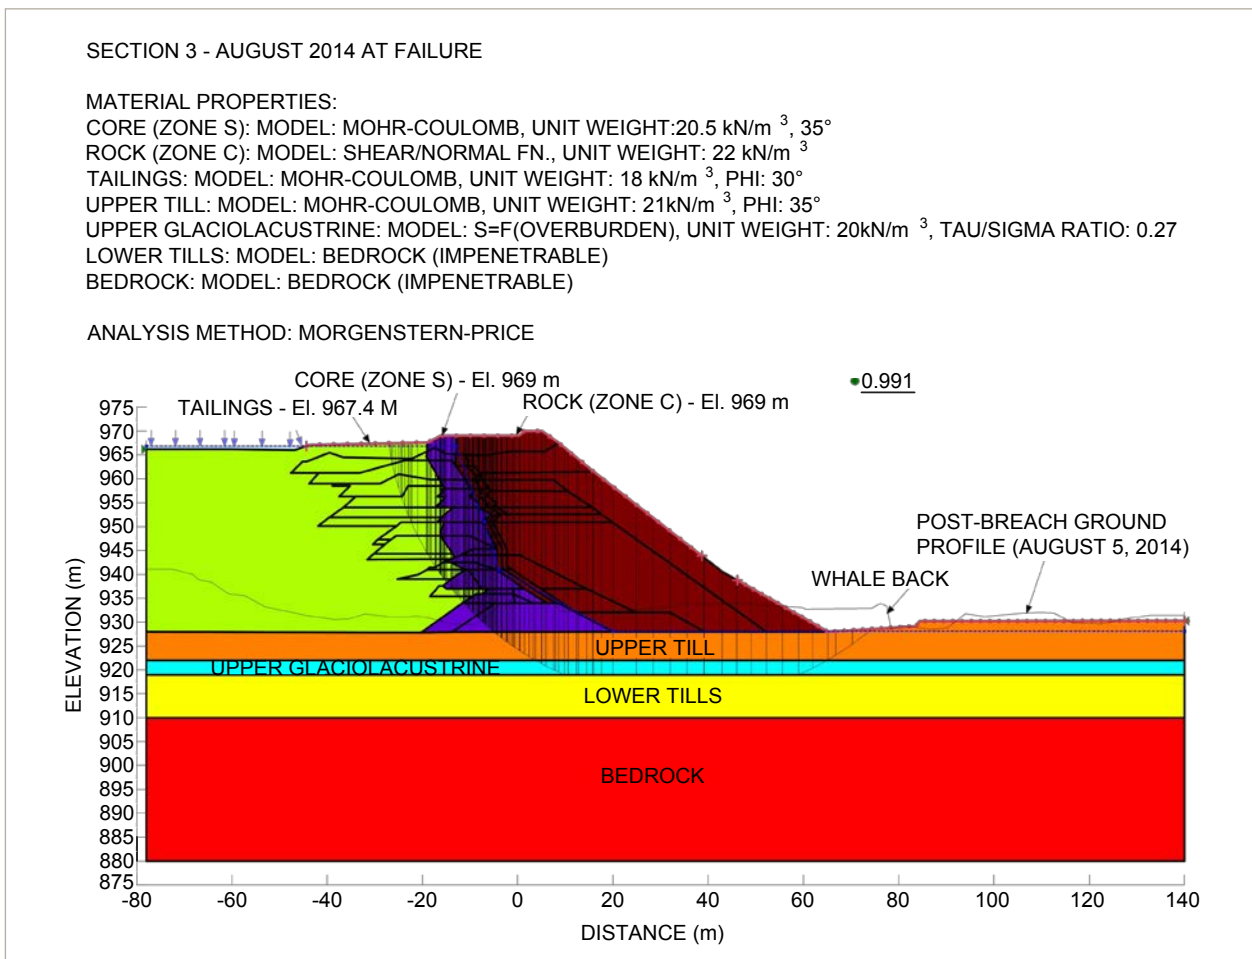
**FIGURE 6.2.1: DETAILED SECTION USED FOR LIMIT EQUILIBRIUM ANALYSIS (HIGH WATER TABLE, UNDRAINED STRENGTH RATIO 0.27)**

Figure 6.2.1 presents the detailed section. It is based on the last LiDAR survey of the embankment prior to failure, a detailed reconstruction of the top of the structure and pond elevation based on construction inspector reports, and it includes a shallow excavation at the toe of the embankment as reported to the Panel. More details associated with the compilation of this and related sections are presented in Appendix H.

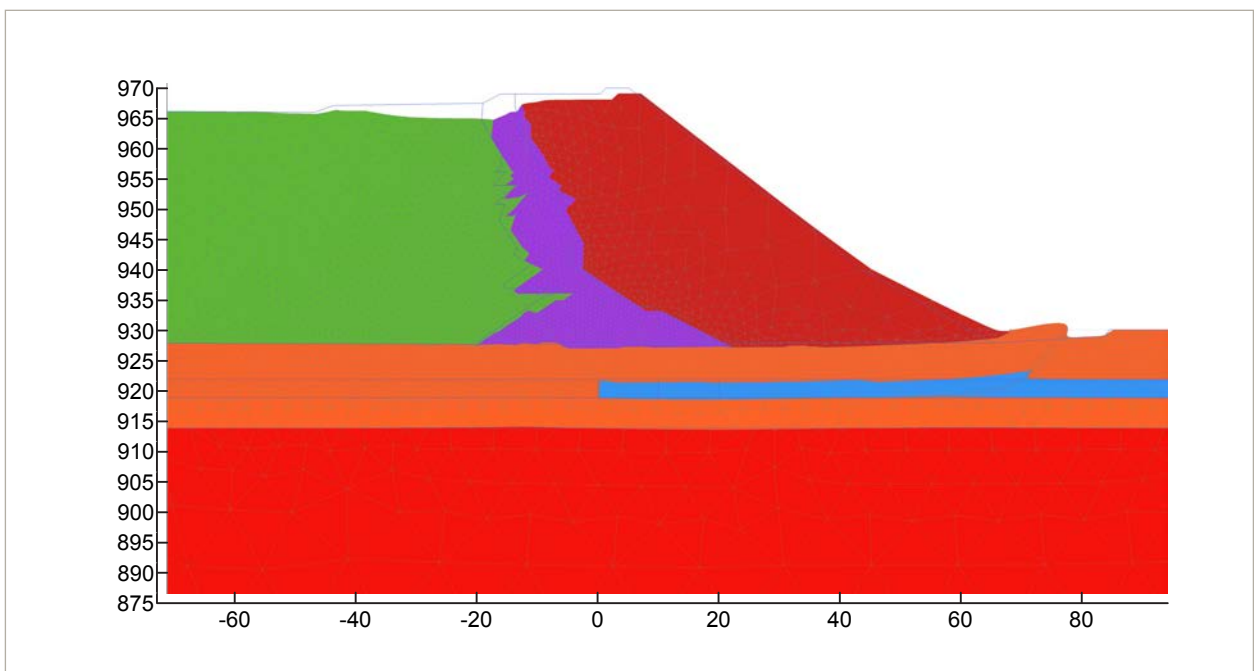
**FIGURE 6.2.4: SCALED-UP FIGURE 6.2.3 TO ILLUSTRATE DEFORMATIONS**

**Figure 6.2.3** portrays the PLAXIS model at collapse. Prior to creating collapse, the model was constructed with essentially the same input parameters as used in the limit equilibrium analyses, except for the Upper GLU that is given a high strength to avoid yielding. The strength of the Upper GLU is then reduced until a deformation mechanism forms and the embankment collapses. This provides not only a measure of the strength of the Upper GLU at which failure occurs, but also an indication of the deformed shape arising from failure. In the model presented in **Figure 6.2.3**, collapse occurred at an undrained strength ratio of 0.29, which is to be compared with 0.27 calculated from the limit equilibrium analysis that incorporates the same boundary conditions. Lower undrained strength conditions would indicate significantly larger deformations. The figure also indicates the zones of localized strain that develop to facilitate motion. Variations of continuity of the Upper GLU with respect to this case yielded similar results.

The PLAXIS analyses provide compelling support for the hypothesis that the movements of the Perimeter Embankment arose due to the undrained failure of the Upper GLU.

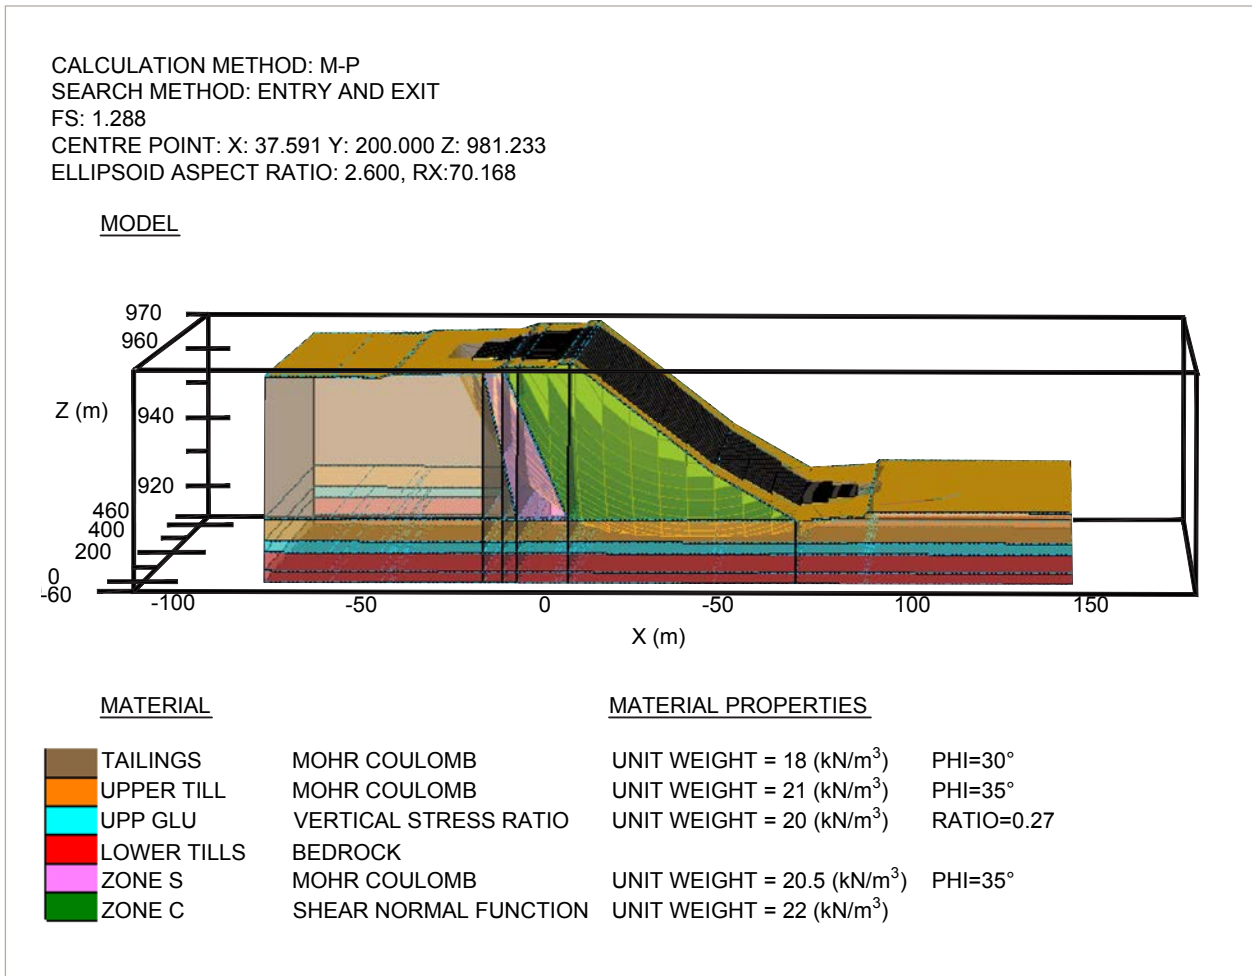
**FIGURE 6.2.5: 3-D LIMIT EQUILIBRIUM ANALYSIS (UNDRAINED STRENGTH RATIO 0.27, ASPECT RATIO 2.6, FS IS ABOUT 1.3)**

The length of the breach is relatively short compared to the height of the Perimeter Embankment at failure (~ 40 m). This is expressed as an Aspect Ratio (length/height) and is calculated to be 2.6. At this Aspect Ratio, three-dimensional restraints might be a significant factor influencing the analysis of the breach mechanism. At small Aspect Ratios, the side resistance acting on the potential moving mass increases in significance. This is ignored in the 2-D analyses described above, which are used routinely in design. Nevertheless, the Panel regarded it of value to assess three-dimensional considerations in order to fully explore the factors affecting the breach mechanism.

Three-dimensional limit equilibrium analyses have been conducted using the computer program SVSlope 3D, a widely accepted program for conducting such analyses. The geometry and boundary conditions are a three-dimensional extension of the case illustrated in **Figure 6.2.1**. All soil properties used in the 3-D analysis are the same as those employed in **Figure 6.2.1**.

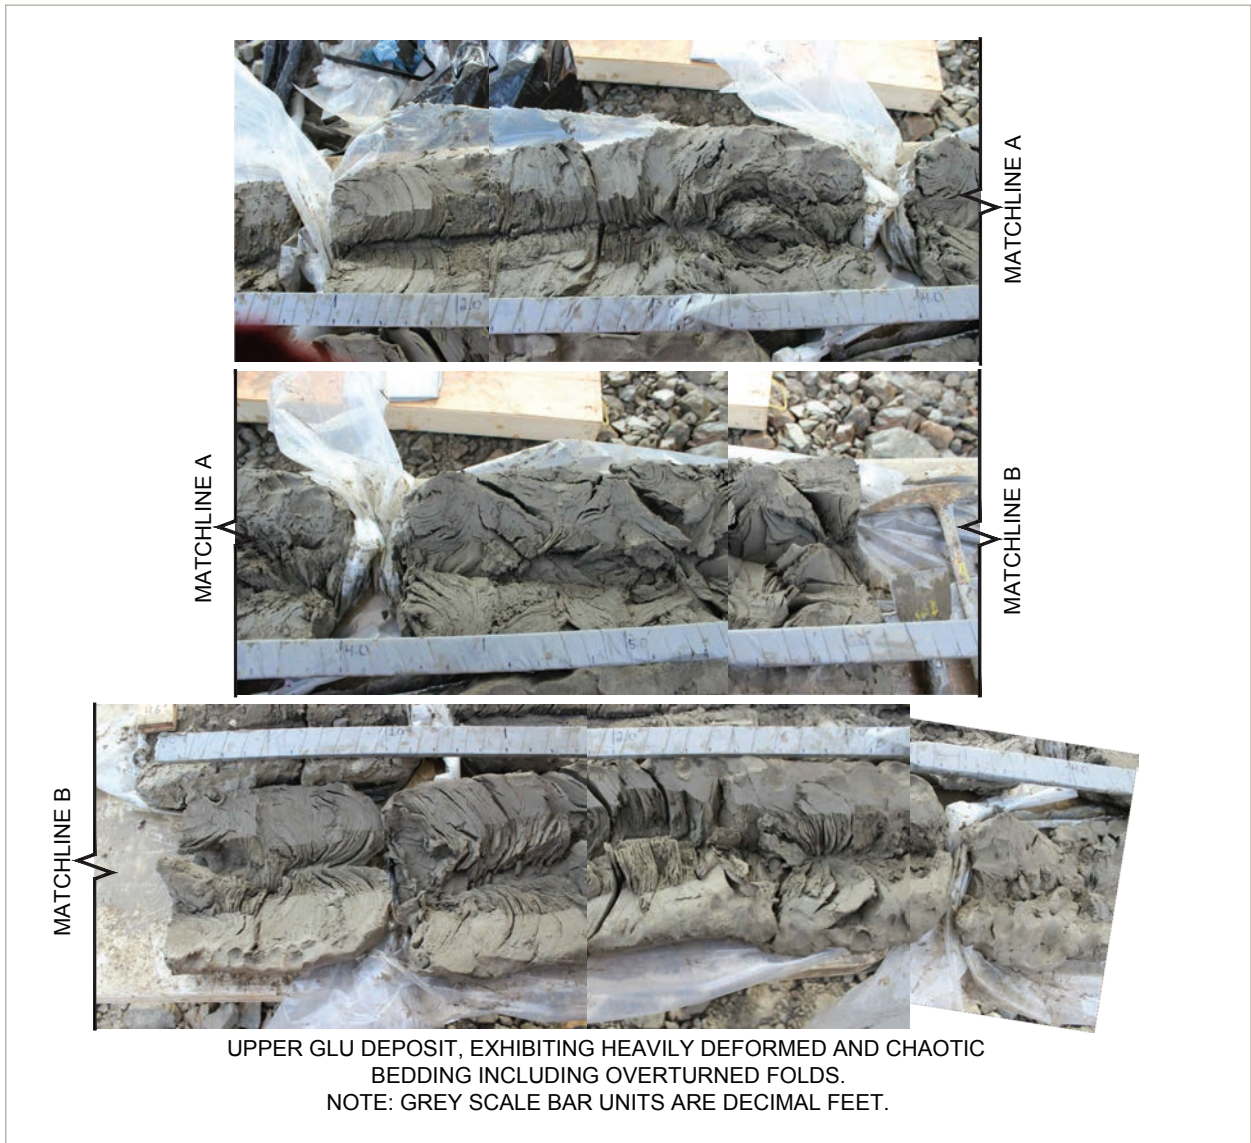
**FIGURE 6.2.6: TYPICAL SHEARING IN THE UPPER GLU**

As shown in Appendix D, Drawing D19, the sensitivities of the Upper GLU in the failure zone is about 1–3, based on CPT-measured tip resistances. Hence, as deformations developed in the Upper GLU, the available resistance reduced due to strain weakening and soil remoulding. Based on the observed sensitivity, it could have dropped to an undrained strength ratio of perhaps 0.13. Repeating 3-D limit analyses with these values yields an FS of about 1.1, which is close to collapse. Hence, as movements developed, the available resistance of the Upper GLU was reduced due to strain weakening to a degree that the three-dimensional restraints to movements at an Aspect Ratio of 2.6 were overcome. The idealizations involved in these 3-D analyses do not permit greater accuracy than expressed here. Going forward, a review of some of the assumed strength parameters that influenced the 3-D modelling and a more detailed representation of local geology that influence the 3-D results would be warranted. **Figure 6.2.6** displays visual evidence of the remolding processes that have occurred due to shearing of the GLU.

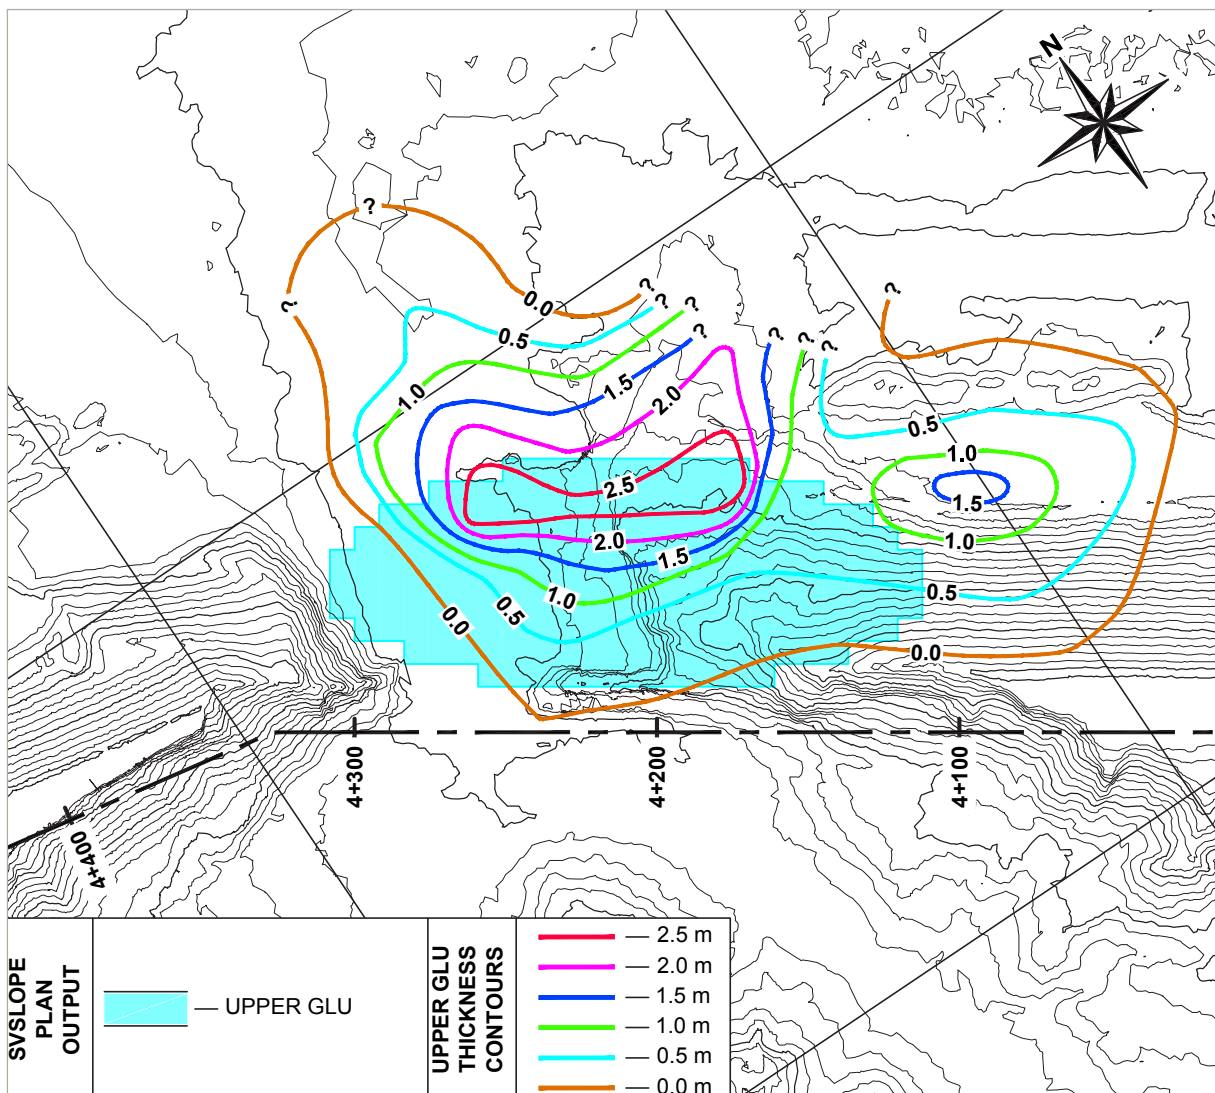
**FIGURE 6.2.7: COMPARISON OF THE 3-D ANALYSIS WITH THE THICKNESS CONTOURS OF THE UPPER GLU**

Additional support for the insight provided by the 3-D interpretation can be found by comparing the footprint of the 3-D analysis with the Aspect Ratio of 2.6 where it intersects the Upper GLU. The distribution of the thickness contours of Upper GLU is presented in **Figure 5.2.6**. This comparison is shown in **Figure 6.2.7**, which indicates a striking fit between the extent of the Upper GLU mobilized in the 3-D analysis (shown in cyan) with the extent of the deepest portion of the Upper GLU.

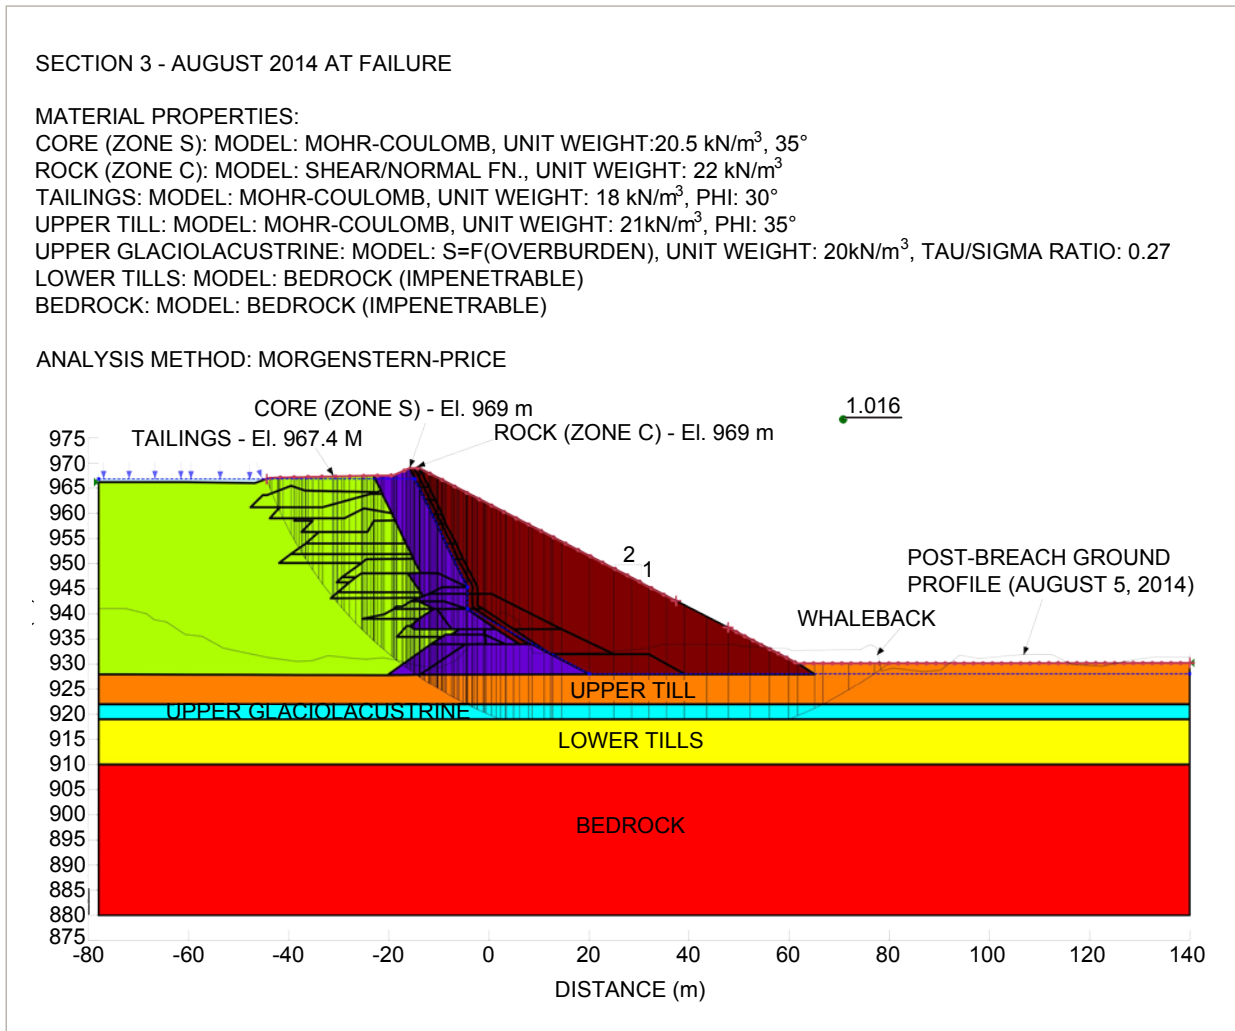
**FIGURE 6.5.1: 2-D LIMIT EQUILIBRIUM 2H:1V SLOPE TO ELEVATION 969 M (UNDRAINED STRENGTH RATIO 0.27, HIGH WATER TABLE, FS 1.02)**

At the time of Stage 4 (2006 – 2007), Knight Piésold (KP) had proposed a design for the Perimeter Embankment with a 2H:1V downstream slope and raises of the core and filter with a parallel inclined alignment to El. 965 m. This design has been projected in **Figure 6.5.1** to the core elevation at the time of failure (El. 969 m), and adopting an undrained strength ratio of 0.27 and a high water table, the calculated FS is 1.02. At El. 965 m, the FS is 1.04, much less than the design target of 1.3. Based on the back-calculated undrained strength ratio, the design was doomed to fail.

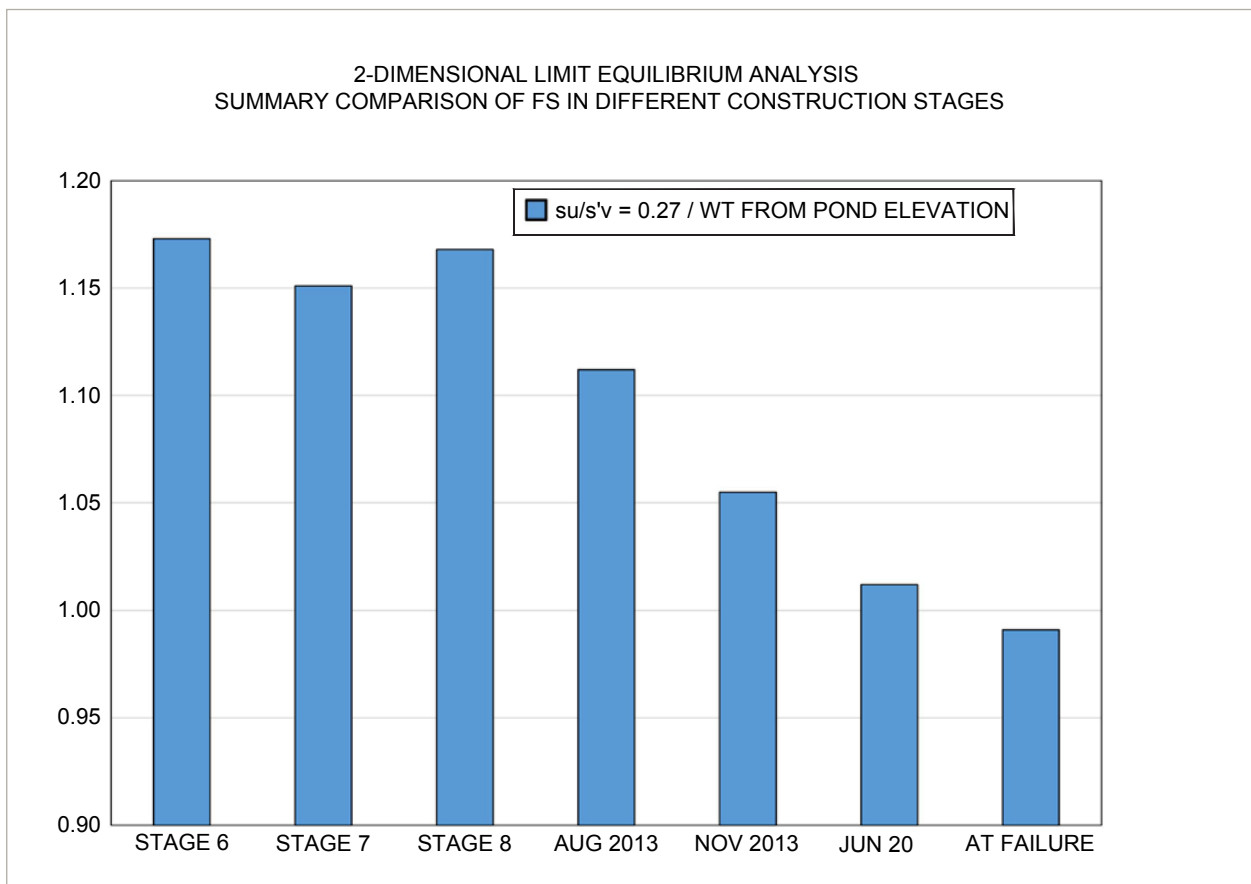
**FIGURE 6.5.2: VARIATION IN FS FOR EACH STAGE FROM STAGE 6 TO FAILURE**

**Figure 6.5.2** shows the variation of the calculated FS with each stage, from Stage 6 to failure, based on the as-built section for each stage. El. 965 m corresponds approximately to the height of the structure at the end of the 2013 construction season. At this stage, the FS is calculated to be only about 1.05, which is similar to the FS for the original design with a 2H:1V slope.

Prior to 2014, the Zone C fill began to be constructed as an angle of repose slope of 1.3H:1V. This appeared to have been an expedient measure and, as illustrated in **Figure 6.5.2**, ultimately resulted in failure of the Perimeter Embankment on August 4, 2014. If constructing unknowingly on the Upper GLU stratum, and not recognizing the potential undrained failure constituted loading the gun, building with a 1.3H:1V angle of repose slope over this stratum pulled the trigger. It appears that the 1.3H:1V
