Review of the Sonoita Creek Mitigation Project Proposal for the Proposed Rosemont Copper Mine

G. Mathias Kondolf, PhD 2241 Ward Street, Berkeley CA mattkondolf@gmail.com

29 December 2017

Report submitted to Save the Scenic Santa Ritas 8987 E. Tanque Verde #309-157 Tucson, Arizona

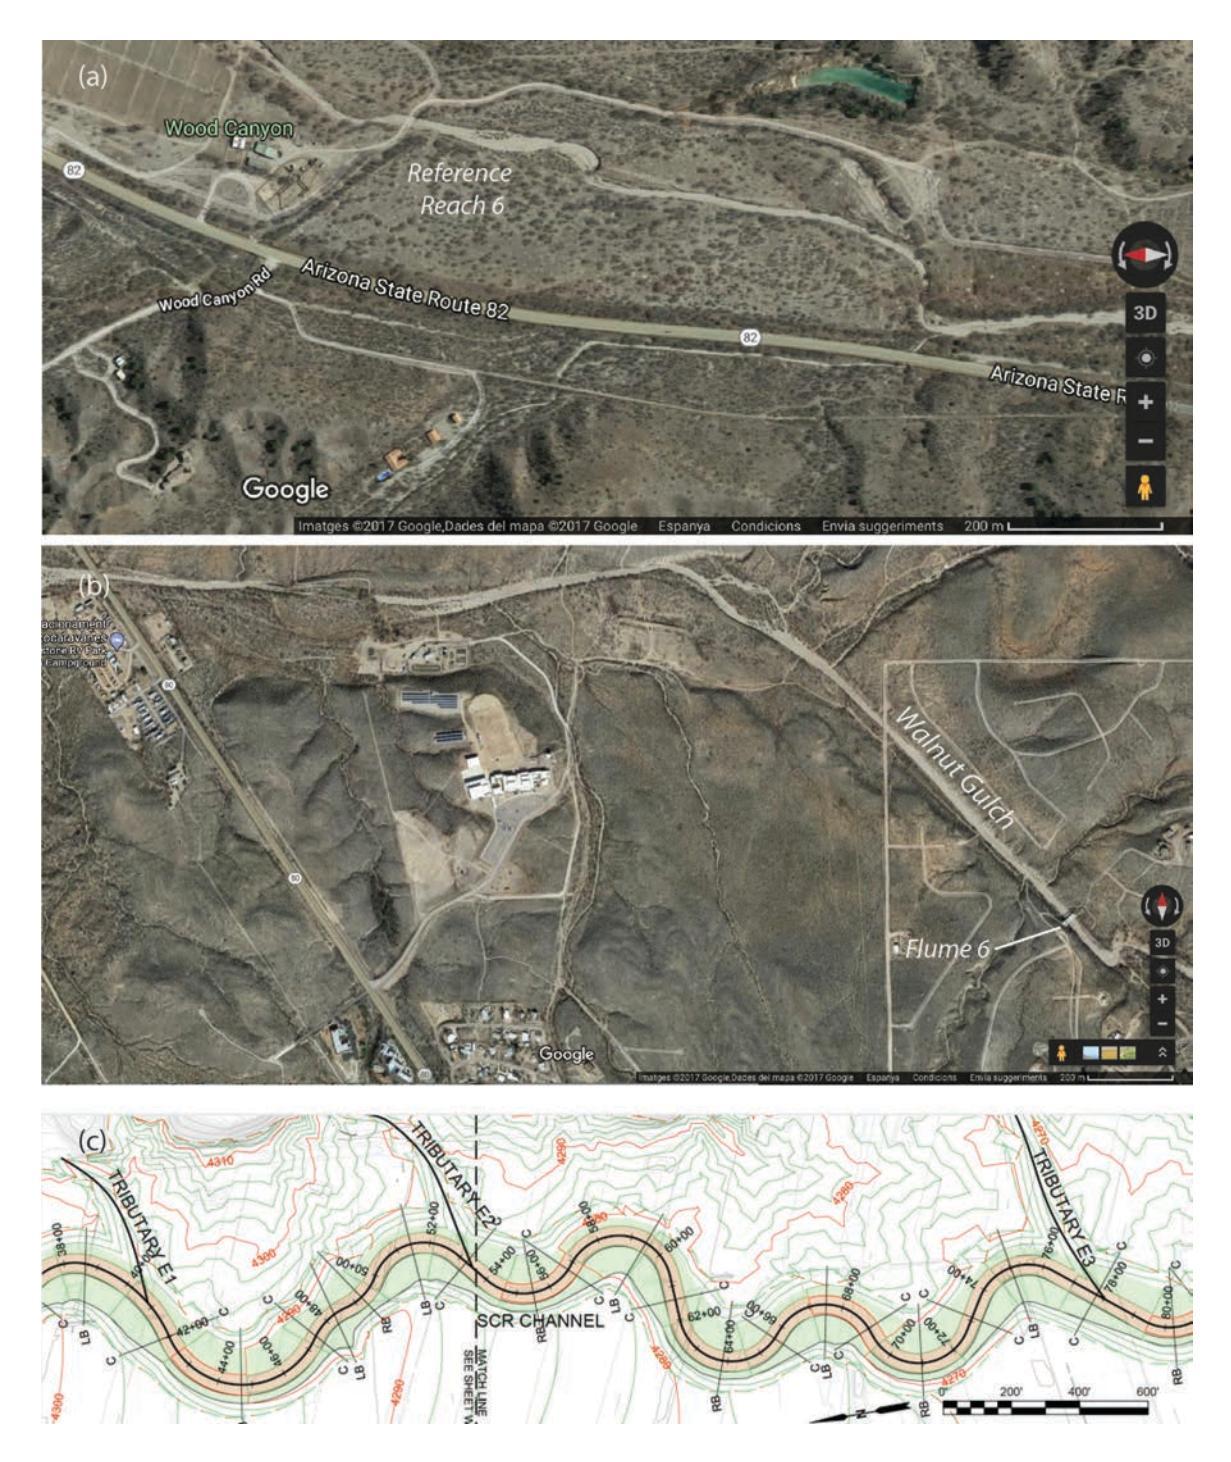
Figure 1. Comparison of channel patterns and sinuosities for reference reaches and proposed reconstructed channel design. (a) Sonoita Creek near Reference Reach 6. (b) Walnut Gulch downstream of Flume 6. (c) detail of proposed channel reconstruction in Sonoita Creek Ranch section. (Source: (a) and (b) from Google Maps; (c) from WET Drawing 11.)

WET (2017:25) states that the reconstructed channel sinuosity "mimics the measured sinuosity of natural, least-altered reaches of Sonoita Creek ...Typical values of sinuosity observed in the least altered reaches of Sonoita Creek ranged from 1.1 to 1.4." This statement is not true. The asserted values do not agree with my independent measurements of sinuosity for the existing reaches of Sonoita Creek. For Sonoita Creek in Rail X Ranch, I measured a sinuosity of 1.07; from 'Reference Reach 6' downstream to the point where Sonoita Creek becomes adjacent to Hwy 82, a sinuosity of 1.07 (Figure 1a); and from the end of the Hwy 82 adjacent section to the road crossing downstream of Reference Reach 8, a sinuosity of 1.29. The latter value is exceptional, occurring only in this more sinuous and dynamic reach. The "typical" values are certainly lower, and well represented by the measured 1.07. Sinuosity does not reach 1.4 on these reaches of Sonoita Creek. At the Reference site 6, which was used by WET (2017) as a basis for design of the proposed channel reconstruction, the channel is nearly straight, as reflected in the measured sinuosity of 1.07.

Similarly, WET (2017) also uses Walnut Gulch near Flume 6, in the Walnut Gulch Experimental Watershed near Tombstone, Arizona, as a reference reach (Figure 1b). This reach is almost perfectly straight before going through an approximately 30-degree bend to the left, and thus depending on the length of reach selected, its sinuosity could be as low as 1.0 (taking only the straightaway before the bend), or about 1.07 (including the bend and continuing downstream to the highway bridge). Thus, this reference reach does not provide support for a highly sinuous channel design on Sonoita Creek.

WET (2017:25) states "The restored channels have a sinuosity that ranges from 1.1 to 1.2." This is false. The proposed channel design is much more sinuous than asserted in this statement, much more sinuous than the existing channels in Sonoita Creek, and more sinuous than the reference reaches in Sonoita Creek and Walnut Gulch (Figure 1).

The proposed meandering channel has a sinuosity of about 1.39, as measured from Tributary E1 confluence to the Tributary E3 confluence (Figure 1c). This would be a very large increase in sinuosity over the typical sinuosity of 1.07 prevailing today. This has significant implications for the proposed mitigation project. As discussed below, to build a channel with such an artificially high sinuosity imposed is likely unsustainable, and after a few moderate storms, the result would probably be that the meander bends wash out, leaving a shorter, straighter channel.

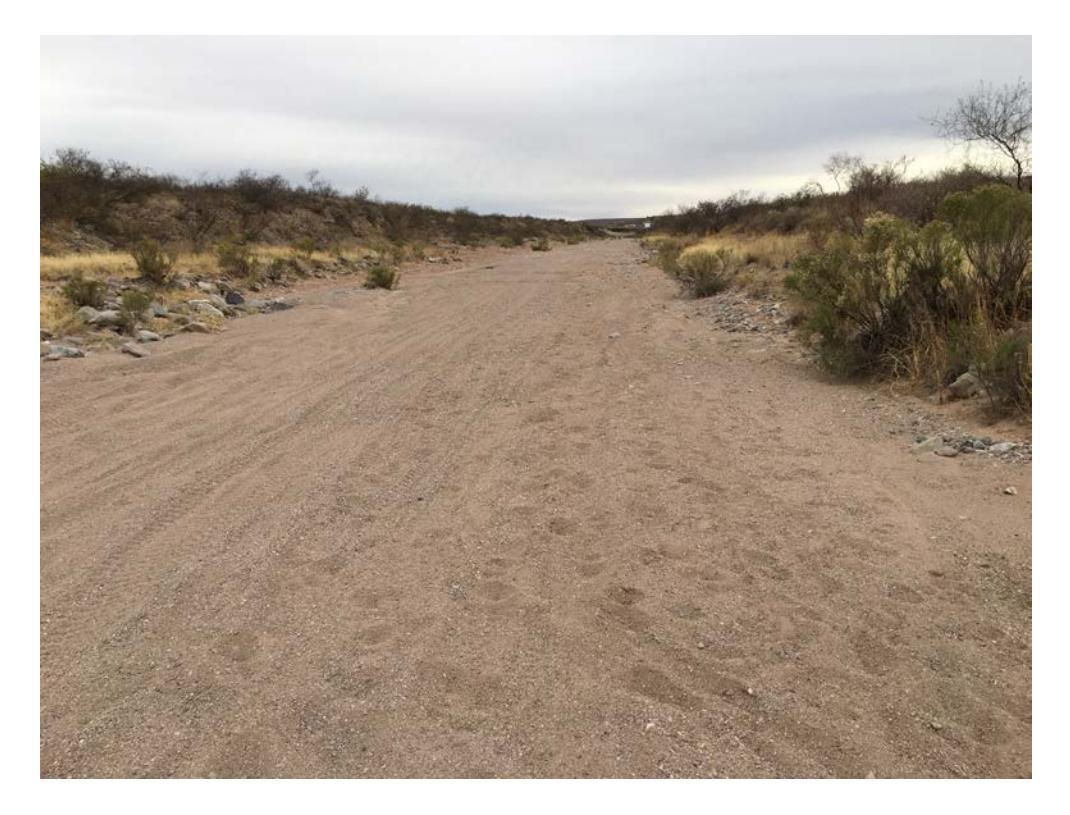
Figure 2. Photo looking upstream along the straight channel of Walnut Gulch towards Flume 6, visible in the distance. (photo by author, December 2017)

WET (2017) and the HMMP use Walnut Gulch (Tombstone, AZ) as a reference reach. Walnut Gulch was established as a USDA experimental watershed in the 1950s, to provide observations and measurements on runoff patterns in a semi-arid environment (Moran et al. 2008, Goodrich et al. 2004). Walnut Gulch drains hills with relatively lowrelief, with no drainage area in higher-relief mountains. Its channel is essentially cut into these hills, with a relatively narrow floodplain in most reaches, and its surface flow is isolated from groundwater, which is at depth. By contrast, Sonoita Creek drains the higher-relief Santa Rita Mountains and the Canelo Hills, which supply flow and sediments in a very different pattern than would be expected in Walnut Gulch. Sonoita Creek in the proposed project areas flows across an alluvial valley floor, with generally shallow water tables, very different from the Walnut Gulch situation. In a section entitled "Comparison of Sonoita Creek to Walnut Gulch Experimental Watershed, WET (2017:13) argues that Walnut Gulch provides "hydrologic and geomorphic analogues to Sonoita Creek" and cites Exhibit 1, which shows strip maps of reaches of Walnut Gulch and Sonoita Creek. The text refers repeatedly to the reach of Walnut Gulch near Flume 6 (one of the measurement stations established for monitoring flow on the experimental watershed), asserting that "Walnut Gulch has numerous reaches exhibiting broad, shallow channel forms with significant braiding near to, and downstream of, Flume 6." (WET 2017:13) The implication is certainly that what we see in Exhibit 1 is illustrating the points made in the text, and indeed Exhibit 1 is annotated with circles to highlight "braided multi-channel areas", supporting the assertions of channel braiding in the text. The problem with this is that the reach shown in the Walnut Gulch map in Exhibit 1 is not the reach near Flume 6, but a reach beginning about 3 miles downstream, with a larger drainage area. The Exhibit 1 map is annotated with a label for Flume 7 (on a tributary drainage) at the extreme right, and for Flume 1 near the center of the map. Contrary to the statements in the text, inspection of aerial imagery of the reach of Walnut Gulch below Flume 6 (Figure 1b) shows that it is nearly all singlethread and very straight (Figures 1b and 2). Nonetheless, the reach of Walnut Gulch near Flume 6 was used by WET (2017) as a reference for channel dimensions for its channel design on Sonoita Creek. The implication that the Walnut Gulch reference reach provides support for a multi-thread or highly sinuous channel design on Sonoita Creek is misleading at best.
