**TECHNICAL MEMORANDUM**

DATE: July 27, 2015

SUBJECT: Conceptual Design for Sonoita Creek, AZ, Technical Review Support (Order  
Number EP-G149-00241)

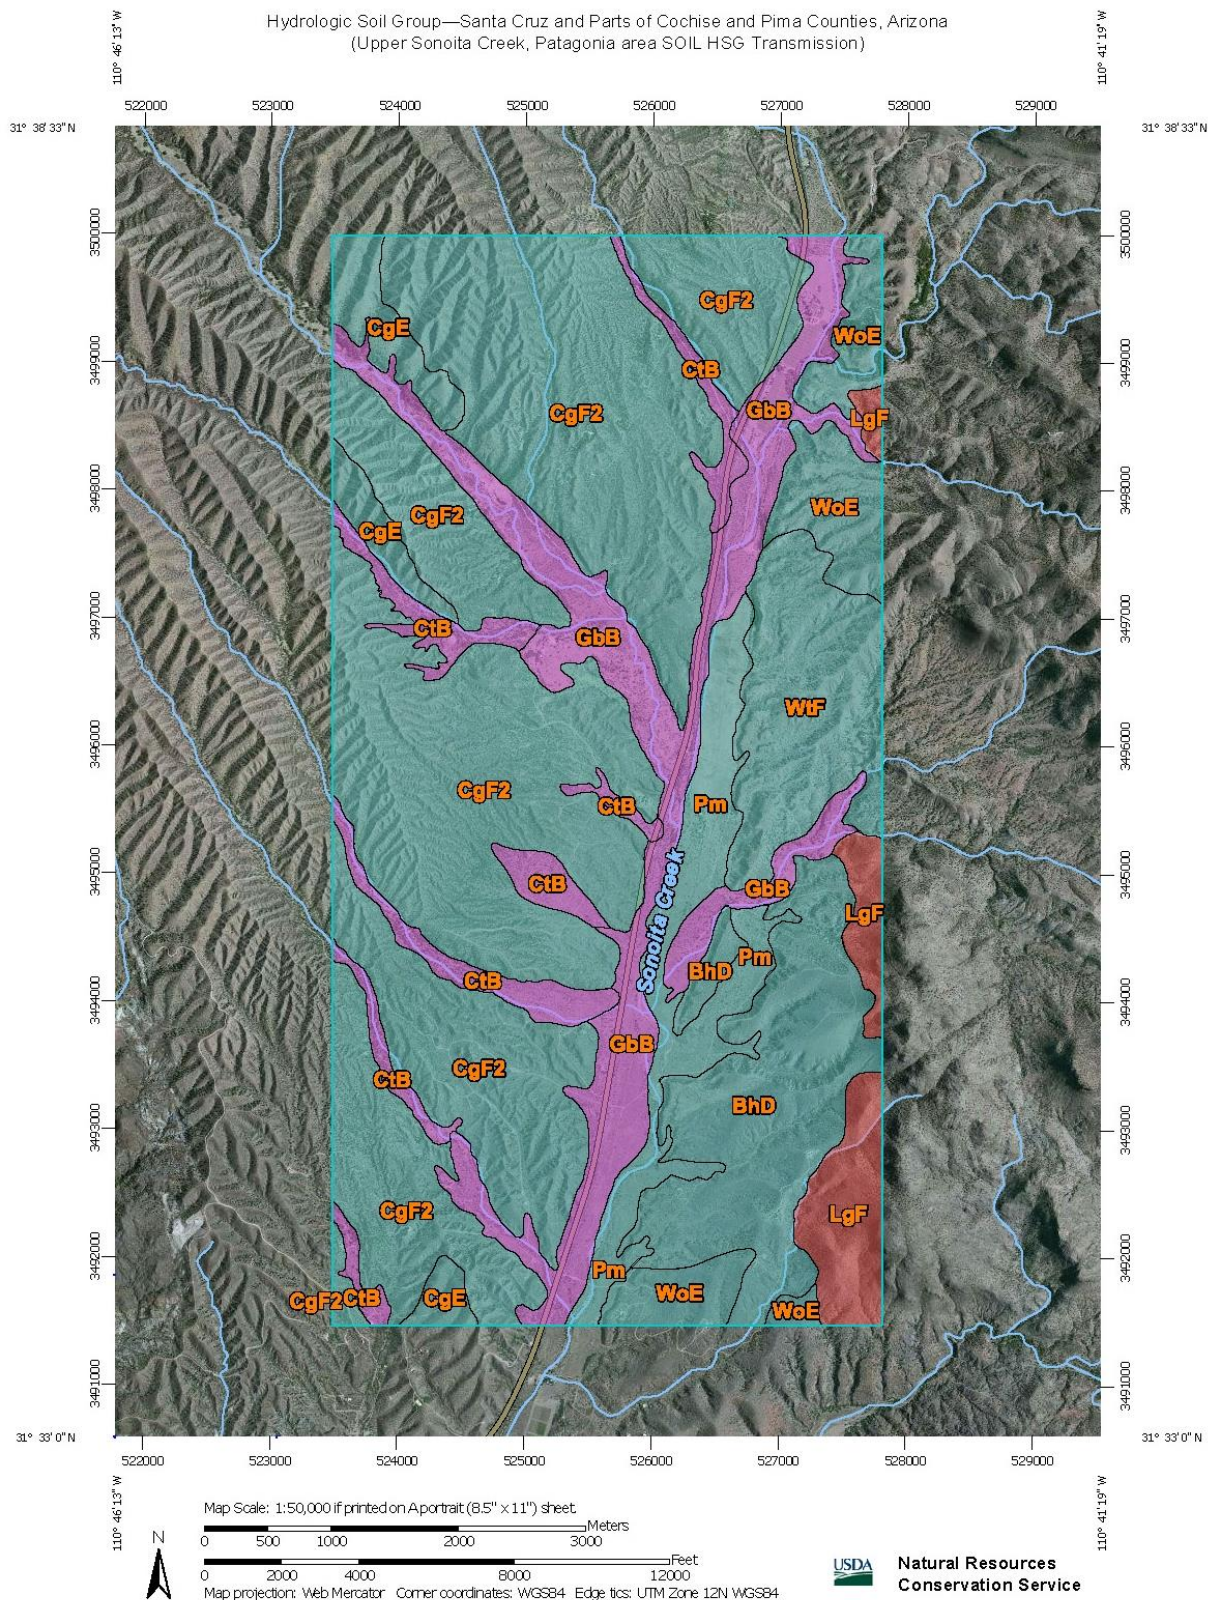
Figure 2a. Hydrologic soil group map and color-coded ratings for Sonoita Creek area (see next page for map legend).

- 3) **The proposed constructed channels will likely not sustain flow in the specific soil types within the project reach.** The Sonoita Creek valley bottom consists primarily of alluvial deposits. In terms of mapped soil units, it is dominated by Grabe-Comoro complex (GbB) soils of gravelly sandy loam to sandy loam composition, that receive a hydrologic soil group classification (HSG) of Group A (refer to Figure 2a and 2b). Group A soils are characterized by high infiltration rates, low runoff potential, and a high rate of water transmission. The Sonoita Creek floodplain also has a lesser percentage of Pima soils (Pm), a clay loam that receives a HSG classification of Group C. Group C soils are characterized by slow infiltration rates and slow water transmission.

Transmission losses due to infiltration into the bed and banks are high in semiarid ephemeral streams, and multiple researchers have demonstrated that except during the highest flows, there is significant loss of in-stream flow due to seepage as the flow proceeds downstream in alluvial valleys (Levick, et al. 2008). The WET report (p.12) notes that transmission losses for streams like Sonoita Creek have been reported as high as 17-29%. Approximately half of the constructed pilot channels as proposed in the plan would be excavated into the highly permeable Grabe-Comoro complex soils, resulting in high transmission losses. Any portion of the flow that entered the newly constructed channels during low to moderate flow rate events, such as those that occur at a high frequency annual scale, would likely not be sustained, and likely not return to the main Sonoita Creek channel. Sediment drops out of suspension as infiltration occurs and flow drops in velocity, depositing new material in the channel. Resulting aggradation may fill the newly constructed channels, further restricting the ability of flows to be diverted and for any diverted flow to successfully return to the main Sonoita Creek channel, particularly at the downstream reaches of constructed channels. Continued aggradation in the constructed channel could eventually create an abandoned, non-functional channel. The overall result would be a loss of habitat in the main channel of Sonoita Creek and a failure to create new habitat in the constructed channels, therefore failing to meet the stated goals of the proposed design in the WET report.

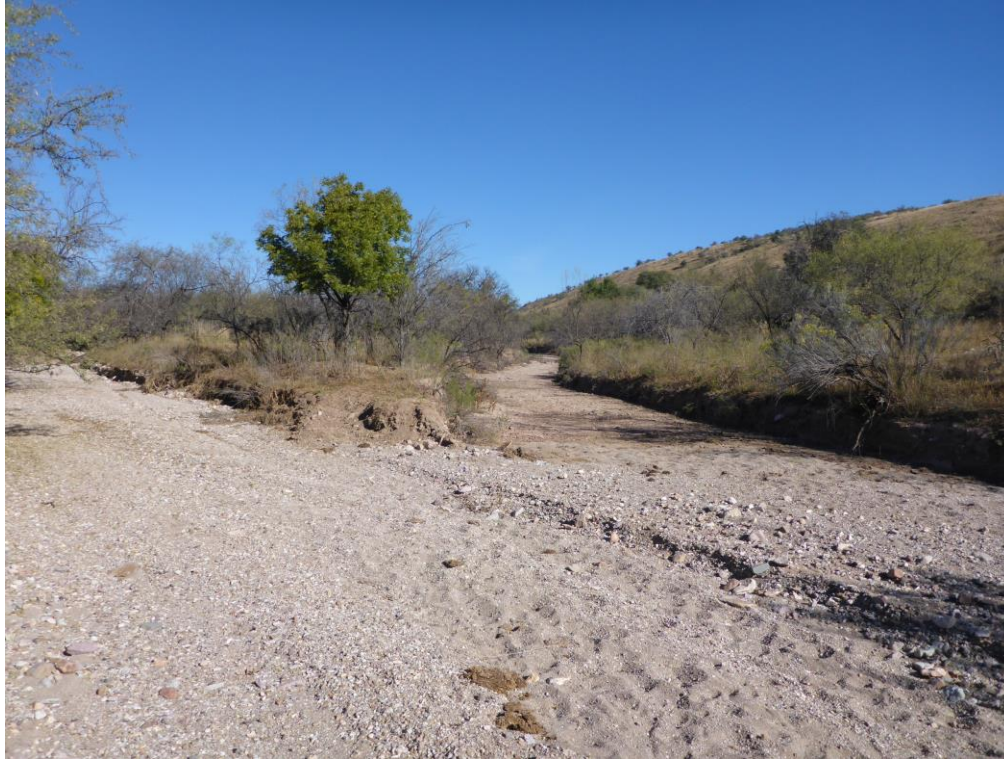
Photograph 1: Confluence of Adobe Canyon and Sonoita Creek. Looking north, Adobe Canyon channel to left, Sonoita Creek channel to right.

main channel, will change over time with normal fluvial geomorphic processes in Sonoita Creek. There is no geomorphic justification to expect that the channels and their junctions will remain unchanged. Even if bank protection and buried riprap were used, experience shows that in such unstable alluvial environments it is difficult to maintain constructed features such as these in a static state. For instance, on the Rail X Ranch Hills North property Lot 3 at the confluence of Adobe Canyon and Sonoita Creek (refer to Appendix, Photograph 1 and 2, as well as Sheet 1 in the end material of the WET report) there is a proposed take-off point for a constructed channel. This area was observed to be very dynamic, and receives high sediment loads from the input of Adobe Canyon. A take-off point into the proposed constructed channel in this area would be subject to the constant influx of sediment and changing channel geometry due to highly dynamic alluvial stream behavior. It was additionally observed for this same proposed constructed channel on the Rail X Ranch Hills North property that in order to accommodate the property ownership currently available to the project, the tie back of the proposed constructed channel into Sonoita Creek must occur before the southern end of Lot 1. This connection would require a specific angle of connection in order to accommodate those property constraints, which would be challenging to maintain given the general dynamic nature of Sonoita Creek, as well as the influence of the proximity to the Adobe Canyon confluence.

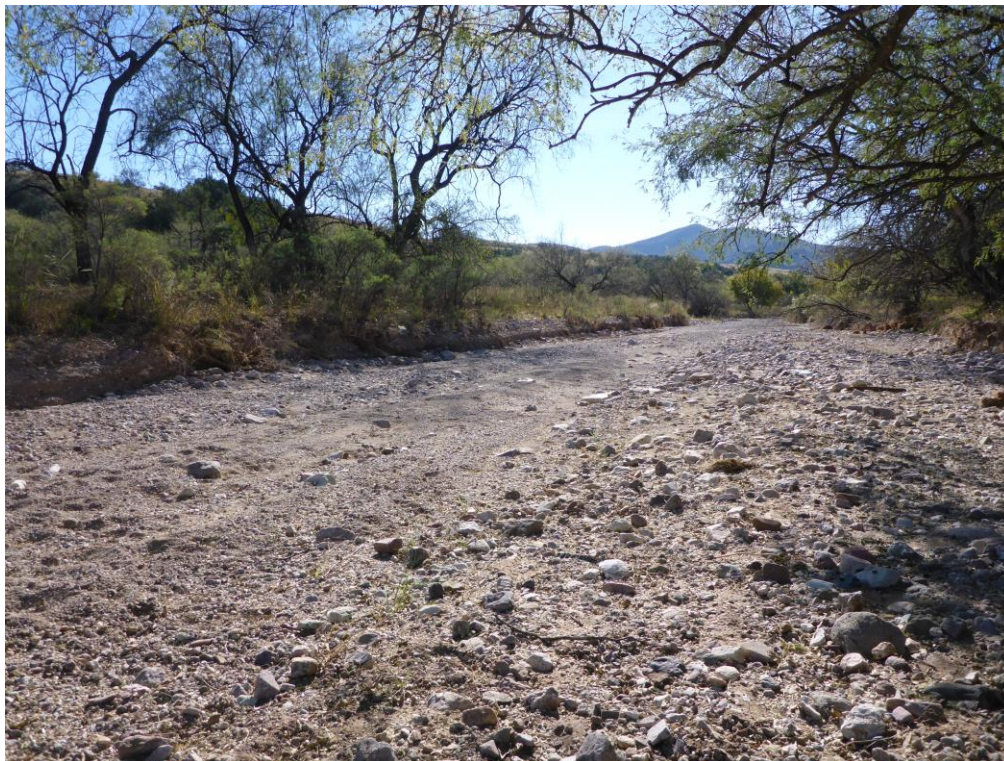
Photograph 2: Looking south from Photograph 1 location, immediately after confluence of Adobe Canyon and Sonoita Creek.

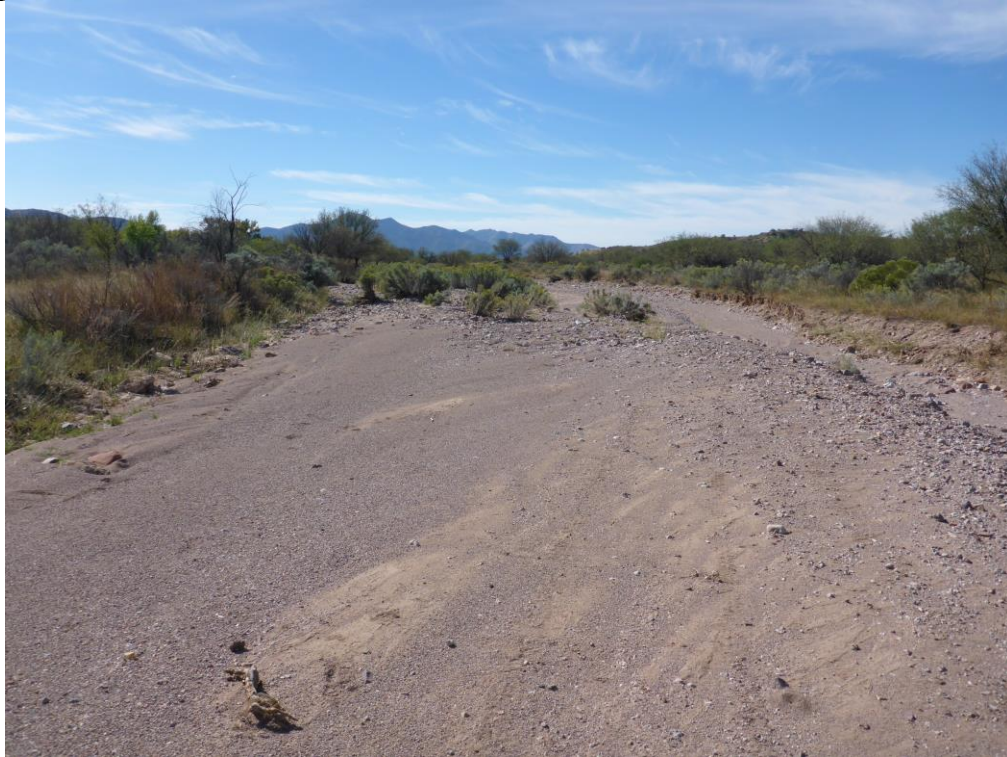
Photograph 3: Example of a typical section of the main Sonoita Creek channel, looking south from photograph location.

Sonoita Creek is a dynamic alluvial channel in a semiarid environment and was observed during the field visit to experience active erosion of its bed and banks, deposition of sediment, and shifts in channel location. Our field reconnaissance was conducted the month after an intense rainfall and runoff in mid-September, and our observations confirmed that the channel displays such active behavior. Especially in the lower-most mile of the proposed mitigation reach, it was observed that during the September 2014 stormflow prior to our visit, Sonoita Creek experienced channel migration, erosion of steep outside banks and deposition of point bars, undercutting and recruitment of trees into the channel, and overbank flow across a portion of its floodplain (see Appendix, Photograph 7 and 8). The downstream-most 6,000 feet of Sonoita Creek located on the Sonoita Spring Ranch property, particularly within Lot 1 through 4, as well as Lot 7 of the Rail X Ranch property, is especially dynamic and complex. We observed a secondary channel developed parallel and east of the main Sonoita Creek channel, and complex patterns of scour and deposition that were created as flow spilled from the main channel into the secondary channel through a wooded island over a distance of approximately 600 ft. The resulting complex fluvial forms provide excellent substrate for establishment of cottonwoods and other riparian trees, and excellent, diverse habitats for birds and other animals. This lower mile of the project reach of Sonoita Creek on the Sonoita Spring Ranch and Rail X Ranch property lots have especially good habitat, with abundant willows and cottonwoods growing on recently established, fresh surfaces that are frequently flooded or subject to lateral erosion.

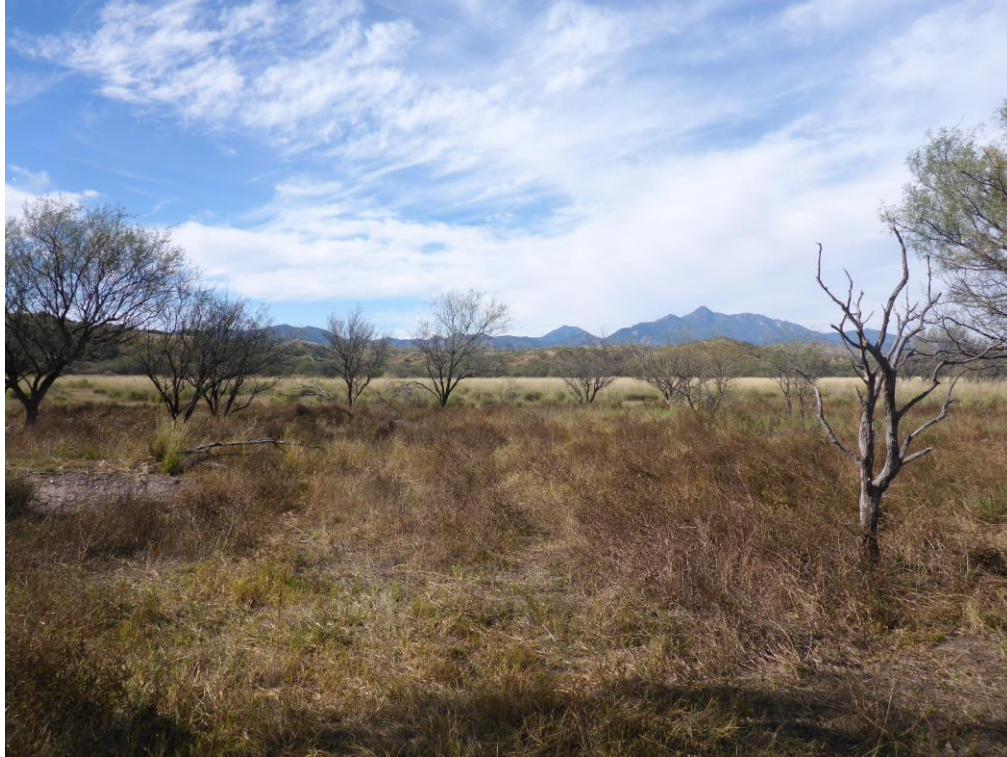
Photograph 5: View looking west from photograph location at example of big sacaton (*Sporobolus wrightii*) grasslands.

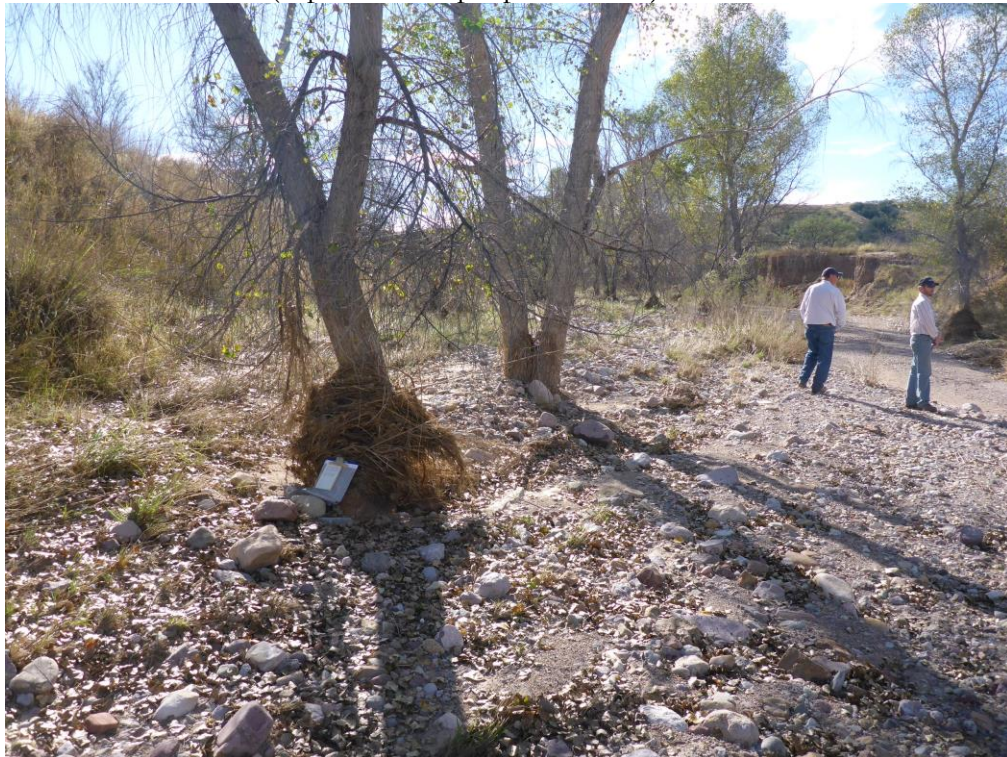
Photograph 6: Looking south, downstream in main Sonoita Creek channel at high water debris around cottonwood tree trunk (clipboard and people for scale).

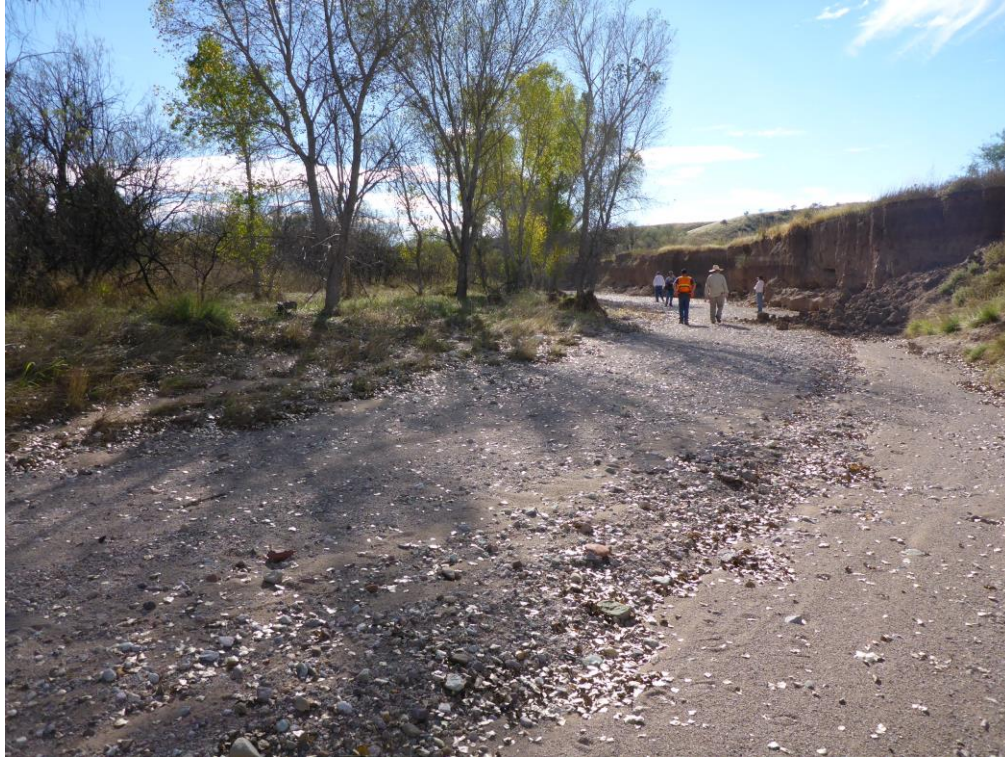
Photograph 7: Additional view looking south within main Sonoita Creek channel at example of cottonwoods population on left bank that are supported by periodic flooding.

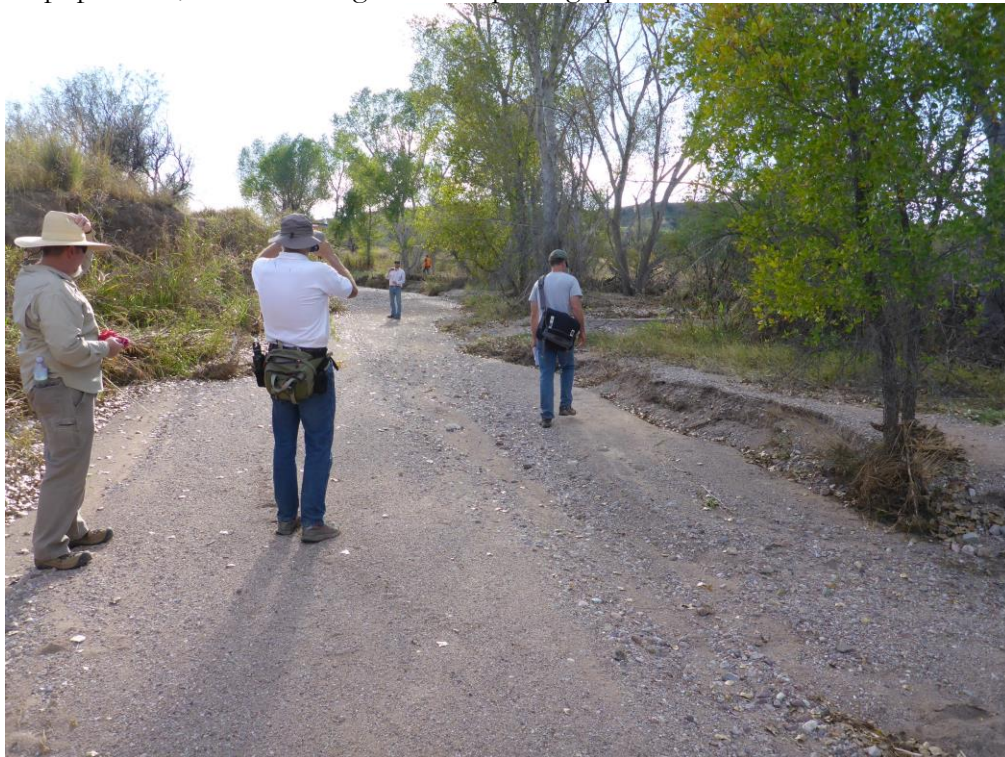
Photograph 8: View looking north in main Sonoita Creek channel at another example of the cottonwood population, seen in the right side of photograph.

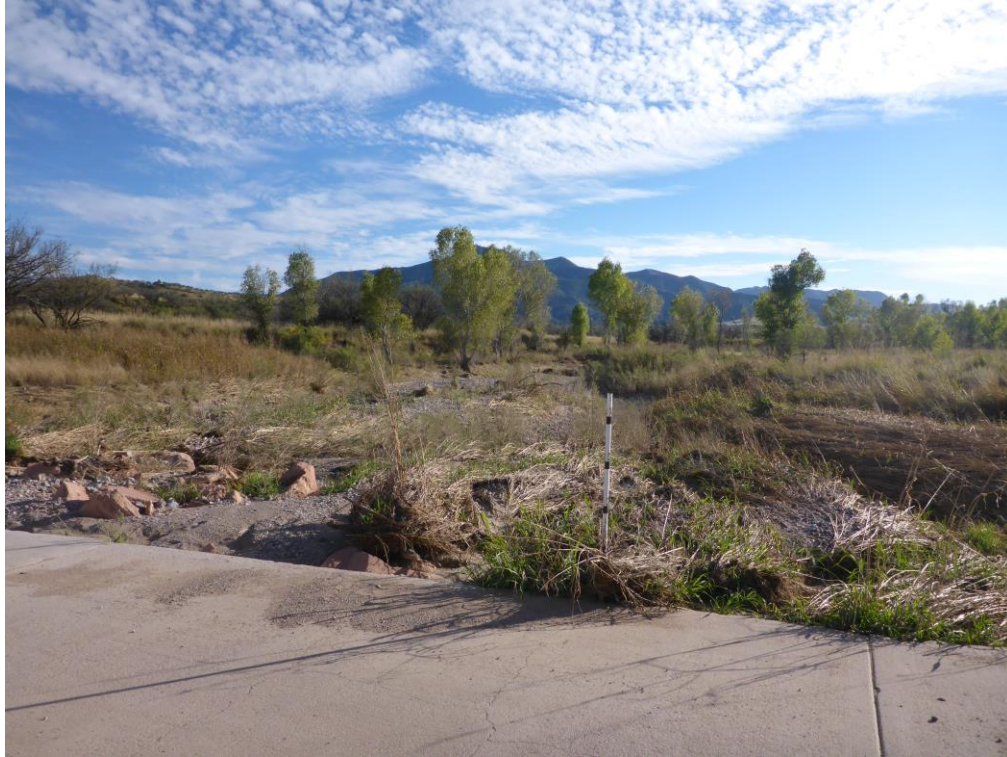
Photograph 9: View looking south within the main Sonoita Creek channel at a concrete road crossing. Further examples of the cottonwood population are seen in the distance.

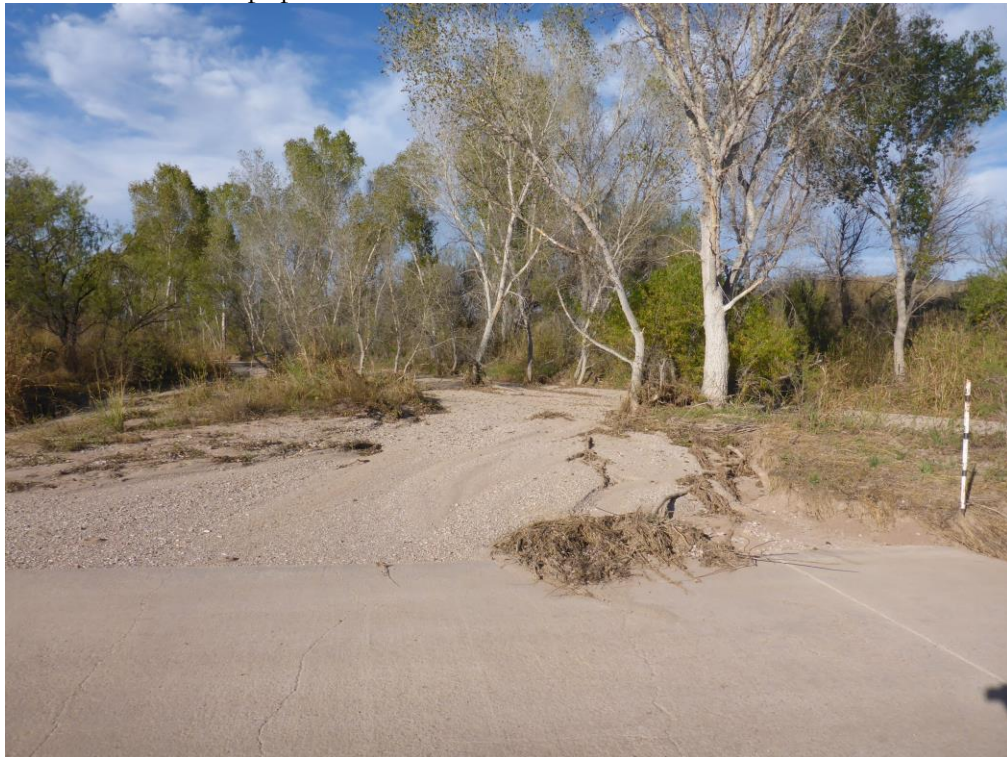
Photograph 10: View immediately north from same location in Photograph 9, with additional examples of the cottonwood population.
